Stormwater Drain Outfall Inspection Report

PROJECT NAME: Needham, MA Stormwater Investigation

Section III. Dry Weather Sampling Procedure and Results, and Drainage Area Descriptions

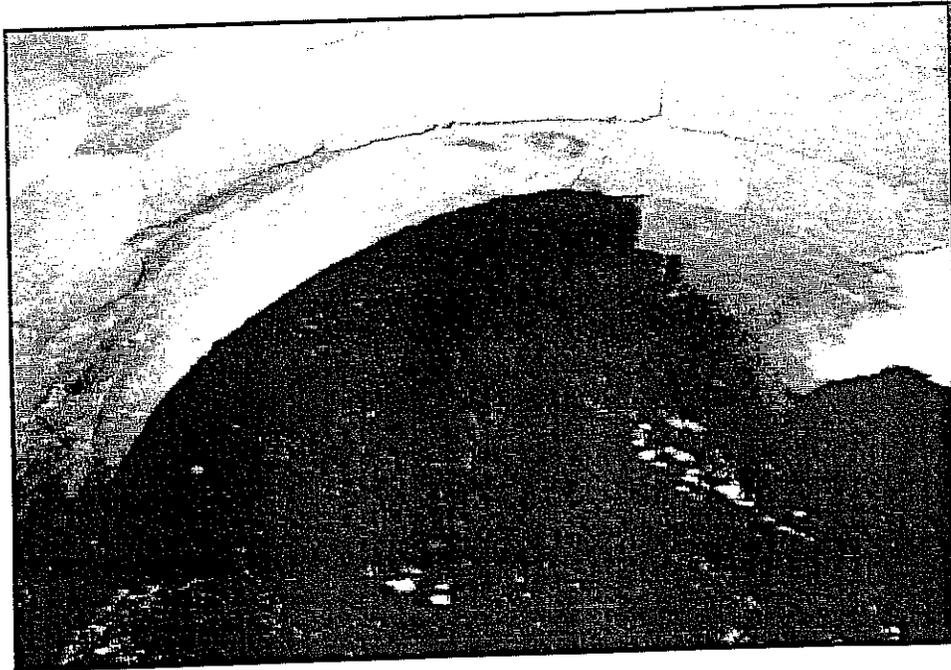
Comments: Visually clean water was observed flowing from this pipe.

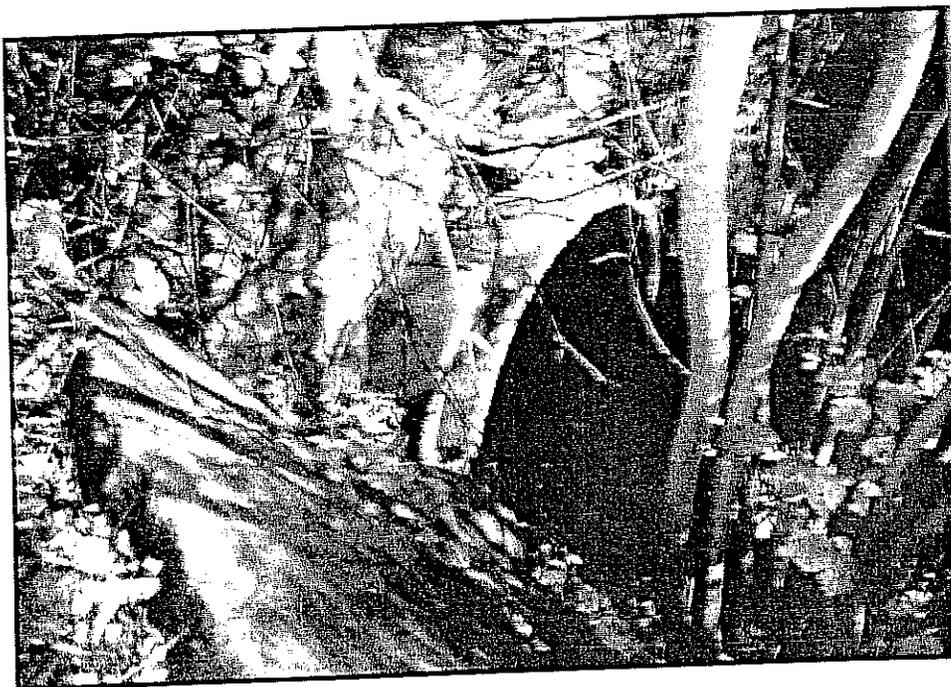
Comments: Visually clean water was discharging from the pipe.

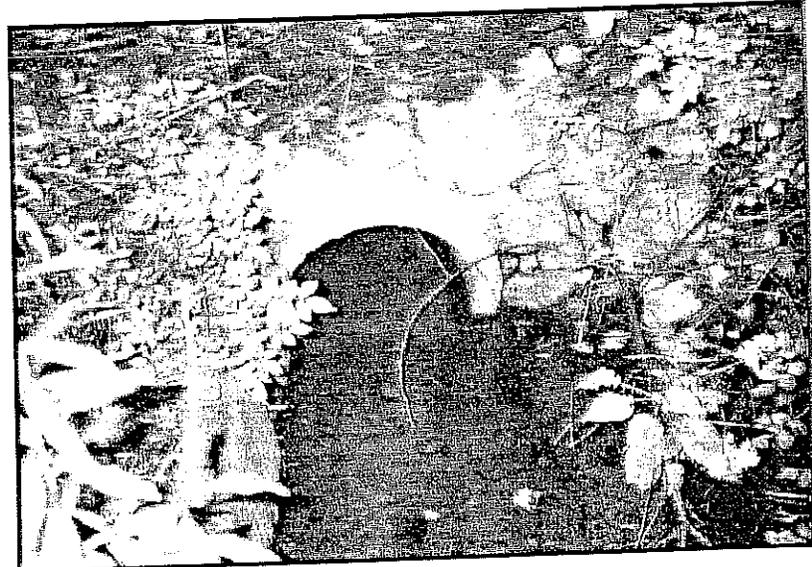
Comments: Iron bacteria noted.

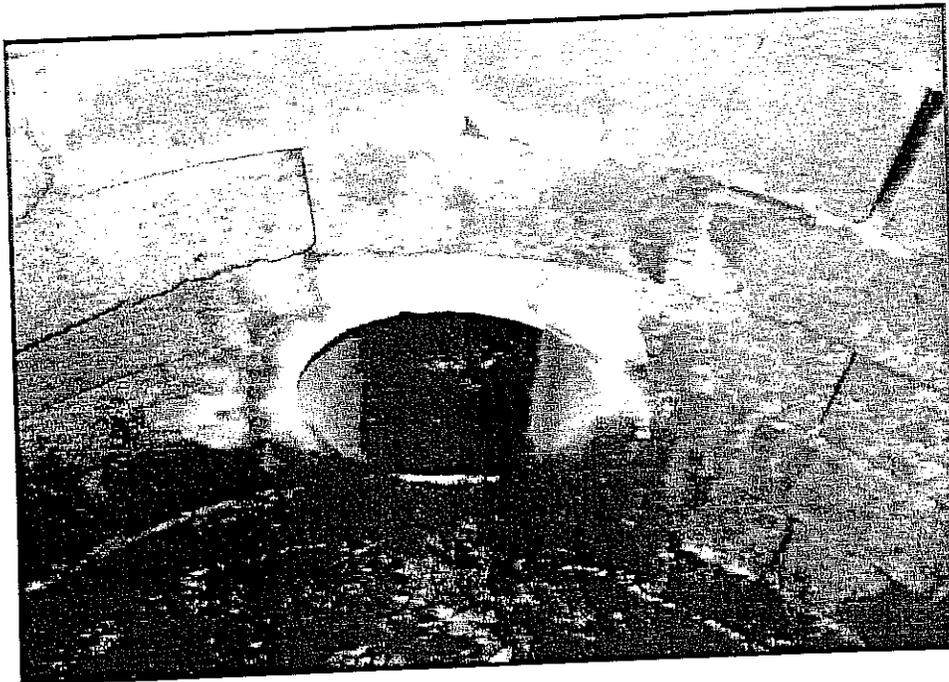
Comments: Visually clean water was flowing from this pipe.

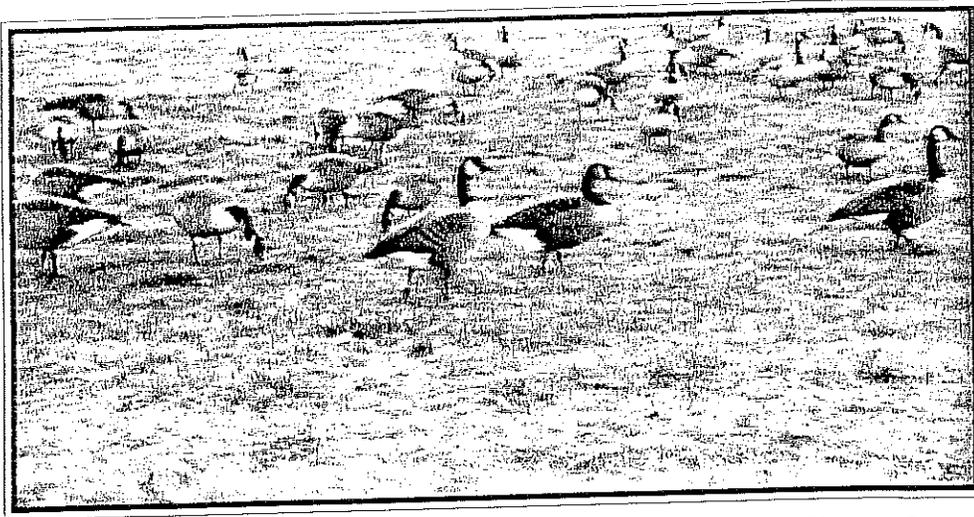
Photo 1: Geese population within sub-area N1 at Walker Gordon Pond, Charles River Street.

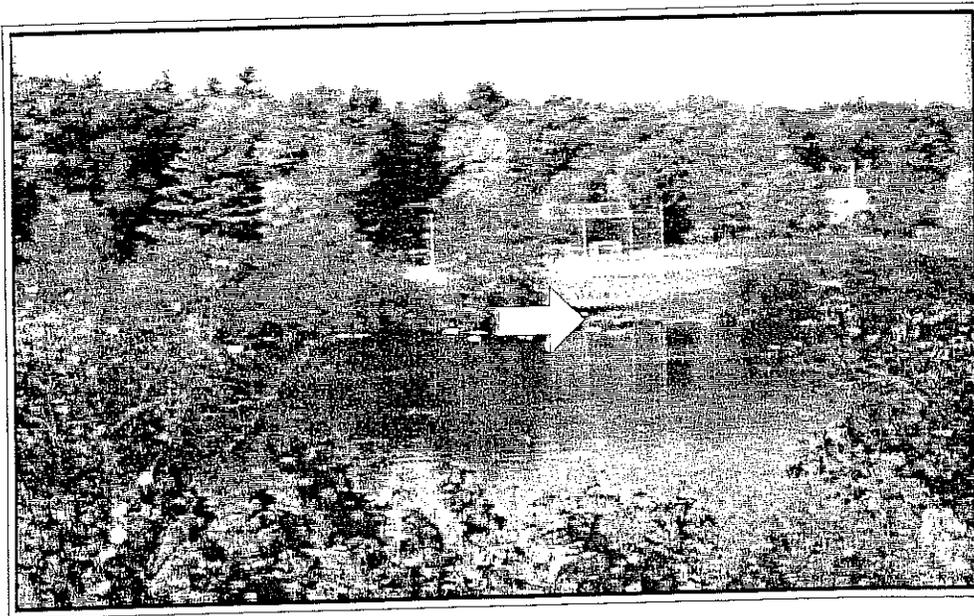
Photo 2: Sampling location N1-3A (refer to the arrow above), Walker Gordon Pond, Charles River Street.

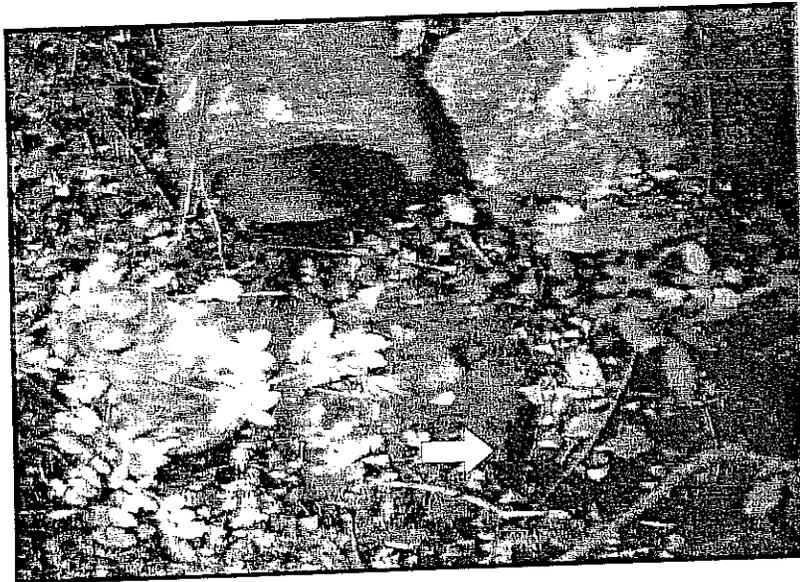
Comments: Discharges directly into Walker Pond. Animal feces were observed at the outfall (refer to the arrow below).

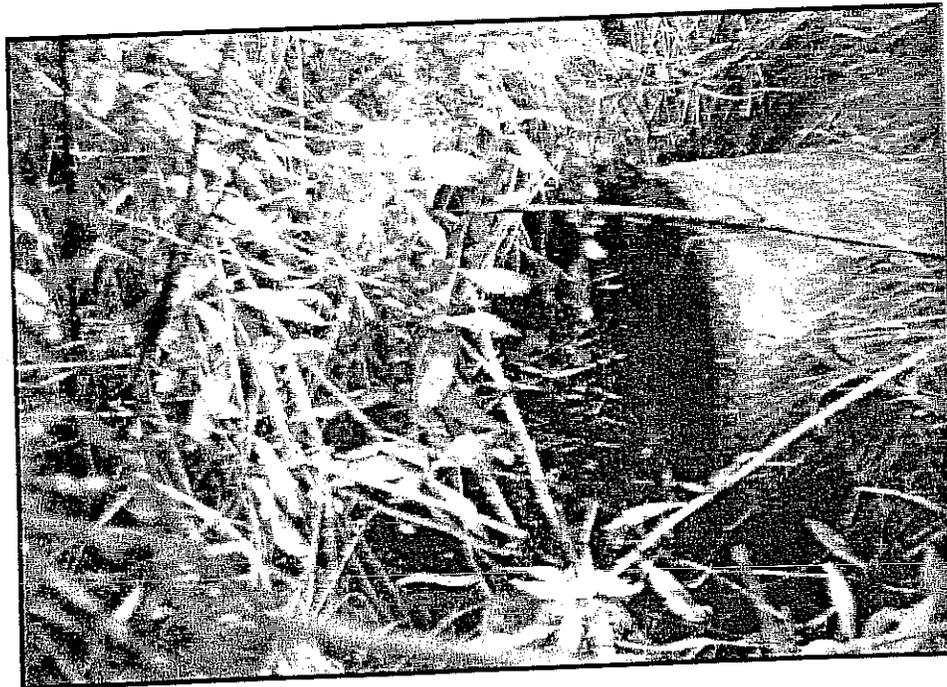
Comments: No debris was located at the outfall.

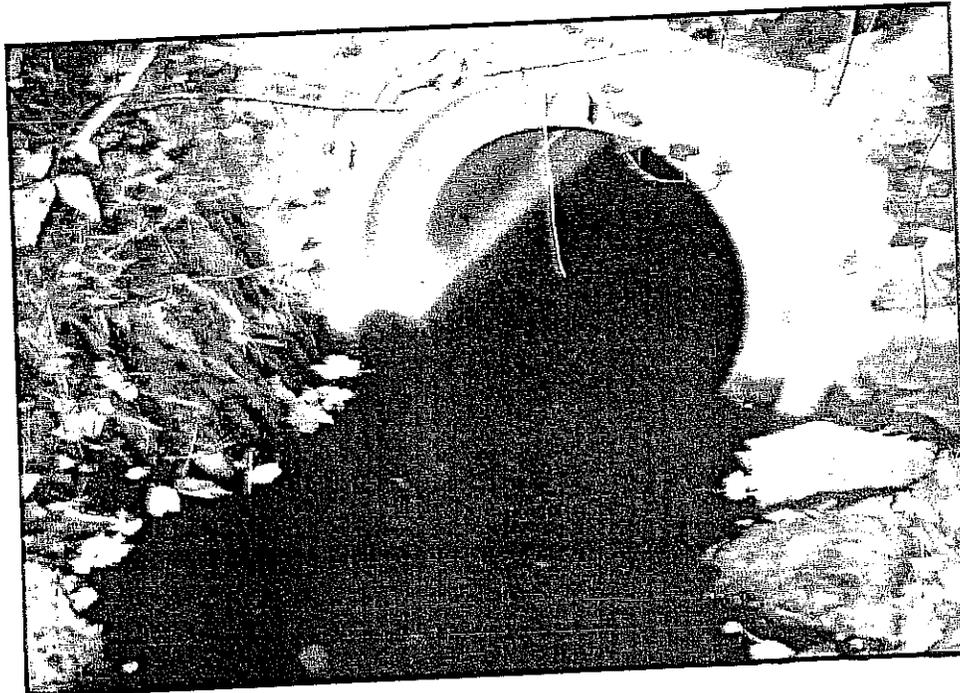
Comments: Minor dark brown organic material was observed in the discharge pipe.
Flow appears to be constant.

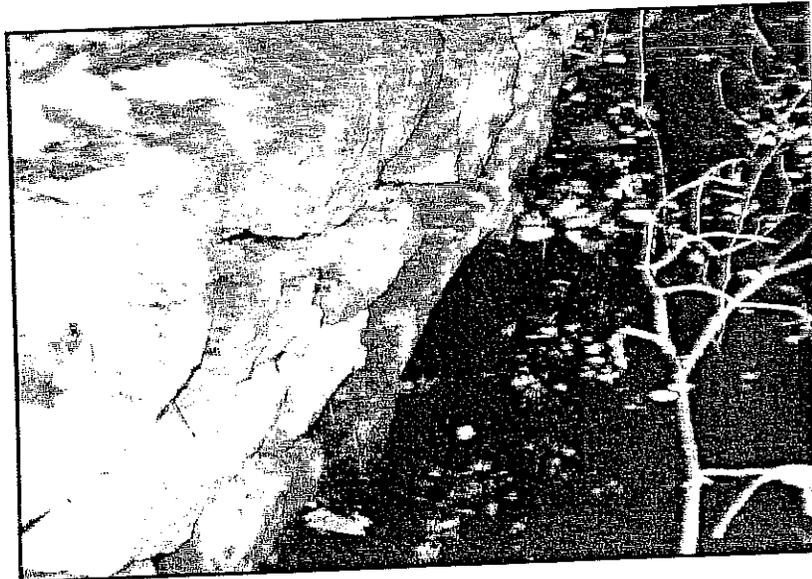
Comments: Visually clean water was observed at the outfall.

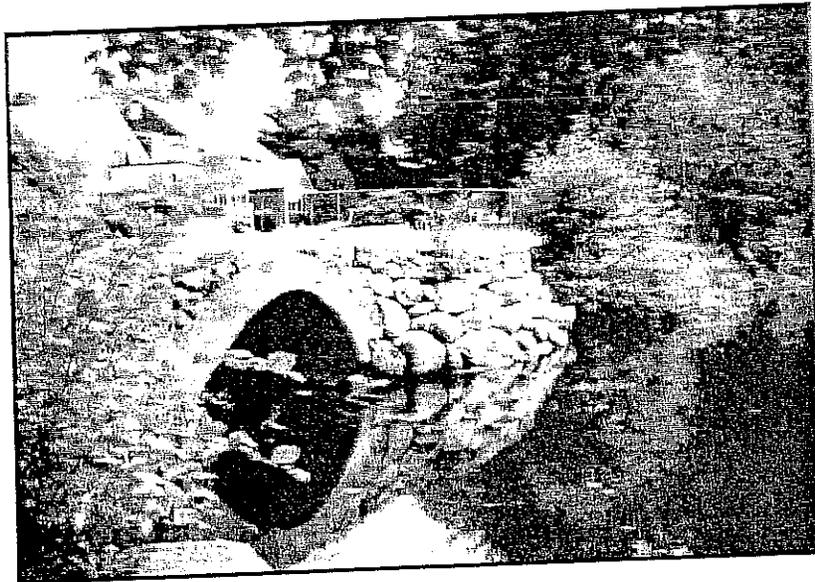
Comments: Visually clear water was discharging through the archway.
