Figure 3.27 - Area Layout
 Drainage Area - N10A
 Needham Stormwater Management

Stormwater Drain Outfall Inspection Report

PROJECT NAME: Needham, MA Stormwater Investigation

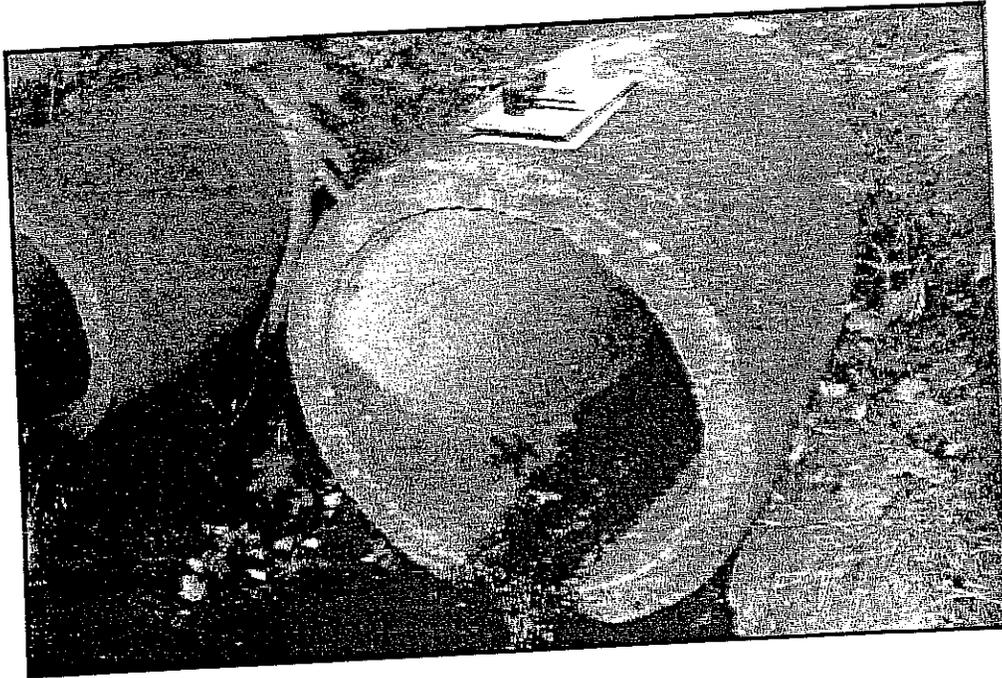
Figure 3.42

Subarea: N10A Discharge Point: N10A-9
Date: 10/17/96 Time: 1:50 p.m. Location: East of Webster St.
Weather: Dry Needham, MA

pH: NS Fluoride: NS mg/l
Conductivity: NS uohms Fecal Coliform Bacteria: 1,600 MPN/100ml
Chloride: NS mg/l Temperature: NS °C

Pipe Size: 36 in. Flow Estimate: 3 gpm
Pipe Material/Condition: RCP/Good Last Precipitation: 10/9/96
Clarity of Flow/Turbidity: Clear

Comments: No organic material was noted in the pipe.

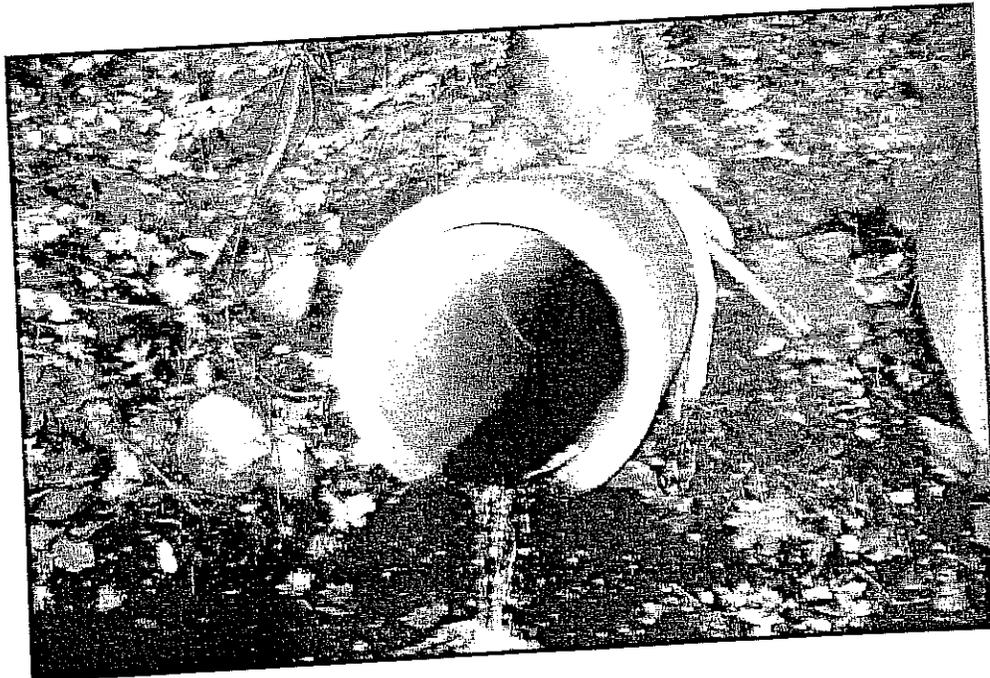
Figure 3.43

Subarea: N10A Discharge Point: N10A-9A
Date: 10/2/96 Time: 3:00 p.m. Location: East of Webster St.
Weather: Dry Needham, MA

pH: NS Fluoride: ND mg/l
Conductivity: NS uohms Fecal Coliform Bacteria: 160,000 MPN/100ml
Chloride: 120 mg/l Temperature: 11.5 °C

Pipe Size: 24 in. Flow Estimate: 10 gpm
Pipe Material/Condition: RCP/Good Last Precipitation: 9/29/96
Clarity of Flow/Turbidity: Clear

Comments: A slime layer was noticed on the bottom of the pipe.

An illicit connection is suspected near Webster Street and the outfall of Area N10A-9A. Detergent suds were noted during several inspections, but only for a brief period of time. Television inspection of a private drain which flows into the municipal drainage system at this location revealed several connections. While these could be sump pumps, detergent suds and elevated fecal coliform have been documented from this private drain. The Town is currently investigating this issue.

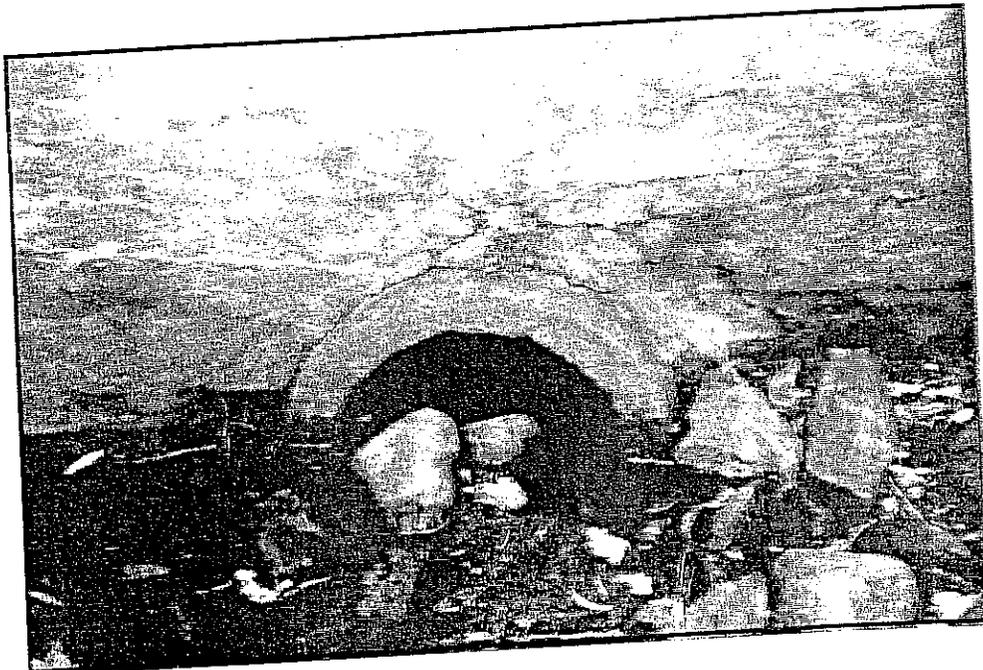
Figure 3.45

Subarea: N10A Discharge Point: N10A-10
Date: 10/8/96 Time: 2:22 p.m. Location: Northwest of Sutton Rd.
Weather: Dry Needham, MA

pH: 6.97
Conductivity: 440 μ ohms
Chloride: NS mg/l
Fluoride: NS mg/l
Fecal Coliform Bacteria: 3,000 MPN/100ml
Temperature: NS $^{\circ}$ C

Pipe Size: 12 in. Flow Estimate: Stagnant gpm
Pipe Material/Condition: RCP/Good Last Precipitation: 10/2/96
Clarity of Flow/Turbidity: Clear

Comments: No floatables were observed at the outfall. Flow partially blocked with debris.

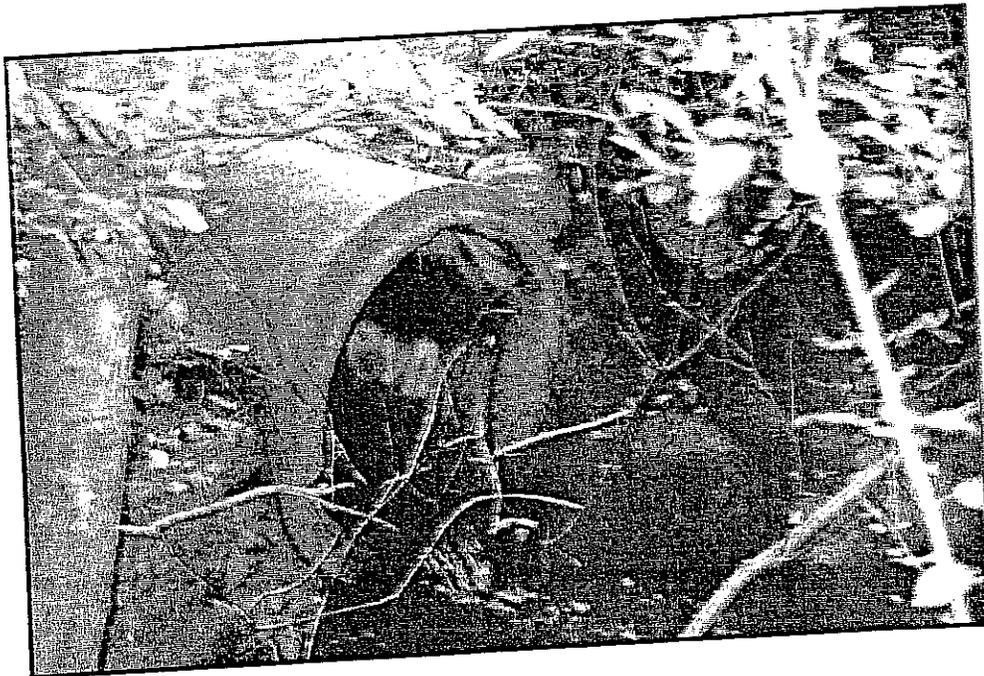
Figure 3.46

Subarea: N10A Discharge Point N10A-11
 Date: 10/2/96 Time 3:20 p.m. Location East of Dedham Ave.
 Weather: Dry Needham, MA

pH: NS Fluoride ND mg/l
 Conductivity: NS uohm. Fecal Coliform Bacteria 80 MPN/100ml
 Chloride: 75 mg/l Temperature 12.4 °c

Pipe Size: 42 in Flow Estimate 10 gpm
 Pipe Material/Condition RCP/Good Last Precipitation: 9/29/96
 Clarity of Flow/Turbidity: Clear

Comments: A slime layer was observed on the bottom of the discharge pipe.

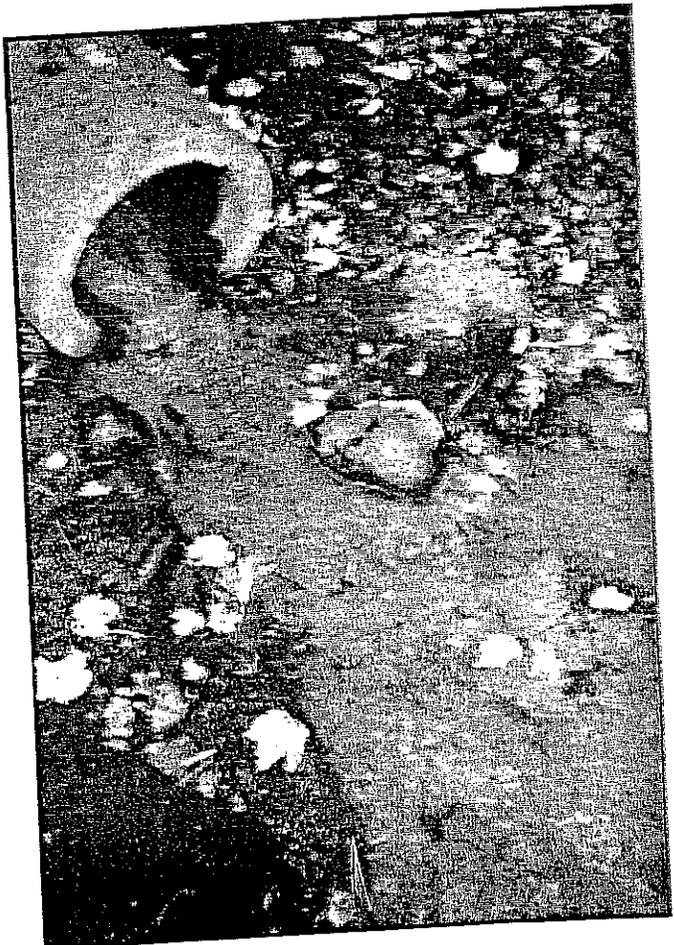
Figure 3.47

Subarea: N10A Discharge Point: N10A-11A
 Date: 10/8/96 Time: 12:30 p.m. Location: East of Dedham Avenue
 Weather: Dry Needham, MA

pH: 6.50
 Conductivity: 390 μohm
 Chloride: 38 mg/l

Fluoride: ND mg/l
 Fecal Coliform Bacteria: 500 MFC/100ml
 Temperature: NS $^{\circ}\text{C}$

Pipe Size: 12 in
 Pipe Material/Condition: RCP/Fair

Comments: Iron bacteria noticed on
the inside of the pipe and at the
outfall.

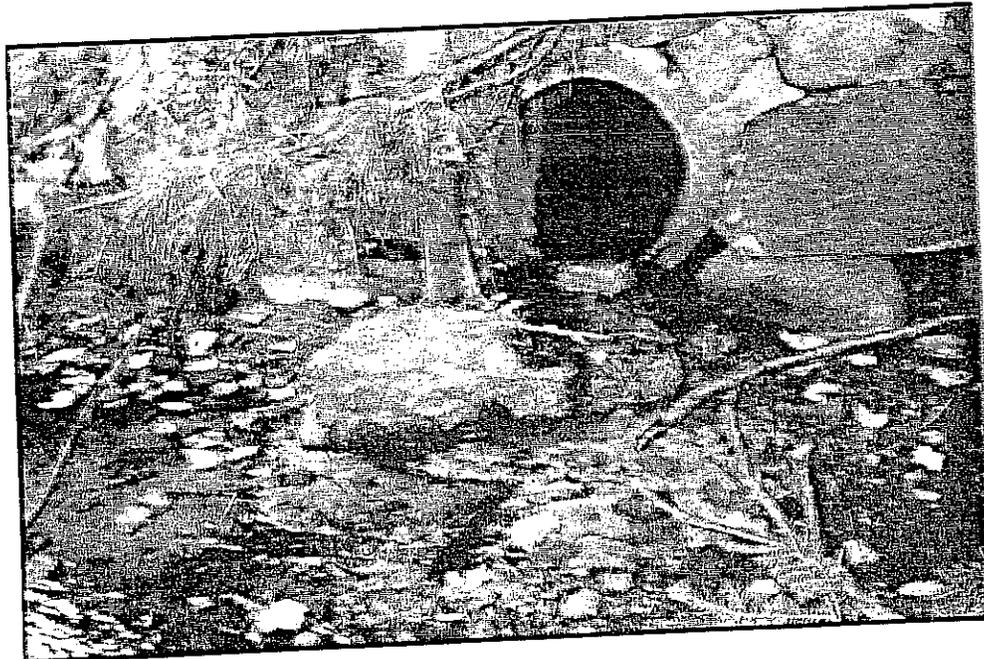
Figure 3.48

Subarea: N10A Discharge Point: N10A-12
Date: 10/8/96 Time: 2:50 p.m. Location: East of Canterbury Lane
Weather: Dry Needham, MA

pH:	7.15	Fluoride	ND	mg/l
Conductivity:	390	Fecal Coliform Bacteria:	23	MPN/100ml
Chloride:	74	Temperature:	11.9	°c

Pipe Size:	12	Flow Estimate:	<0.5	gpm
Pipe Material/Condition:	RCP/Good	Last Precipitation:	10/2/96	
		Clarity of Flow/Turbidity:	Clear

Comments: Iron bacteria was located in the pipe and on the outfall rocks.

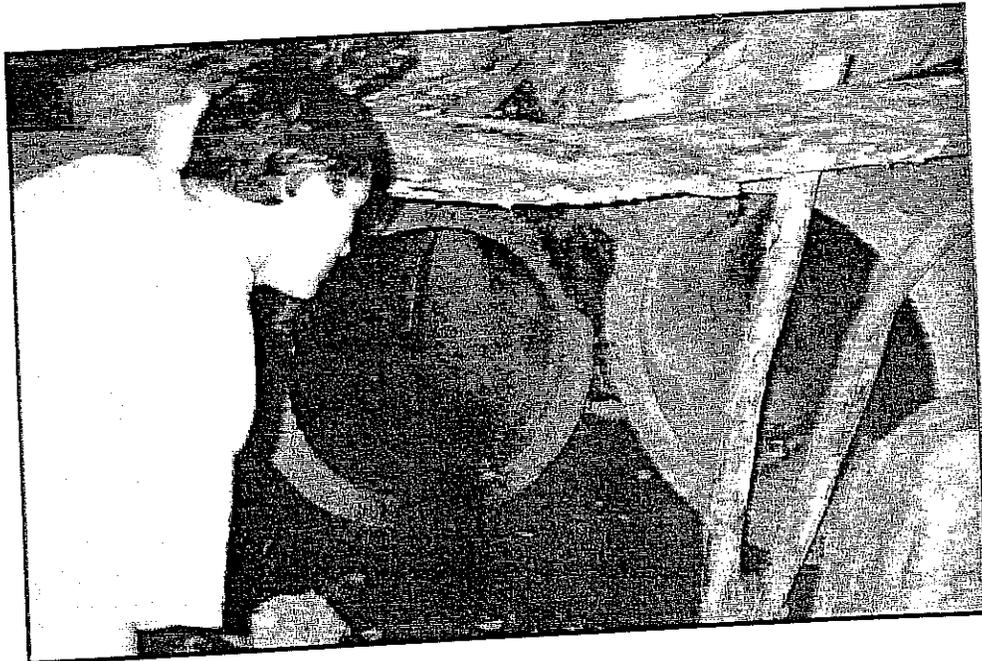
Pipe Size: 24 in Flow Estimate: Dry gpm
Pipe Material/Condition: RCP/Good Last Precipitation: 10/2/96
Clarity of Flow/Turbidity: NA

Comments: N10A-14 is located on the right hand side of the picture below, adjacent to N10A-6.

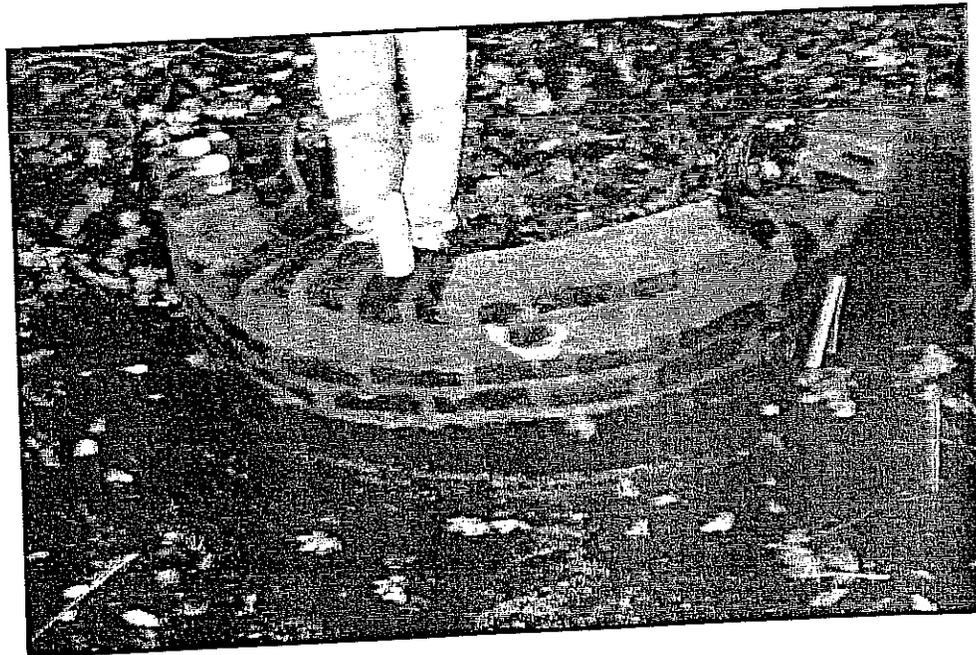
Pipe Size: NA m Flow Estimate: <0.5 gpm
Pipe Material/Condition: NA Last Precipitation: 10/2/96
Clarity of Flow/Turbidity: Clear

Comments: The water appears to be groundwater flowing out of the ground.

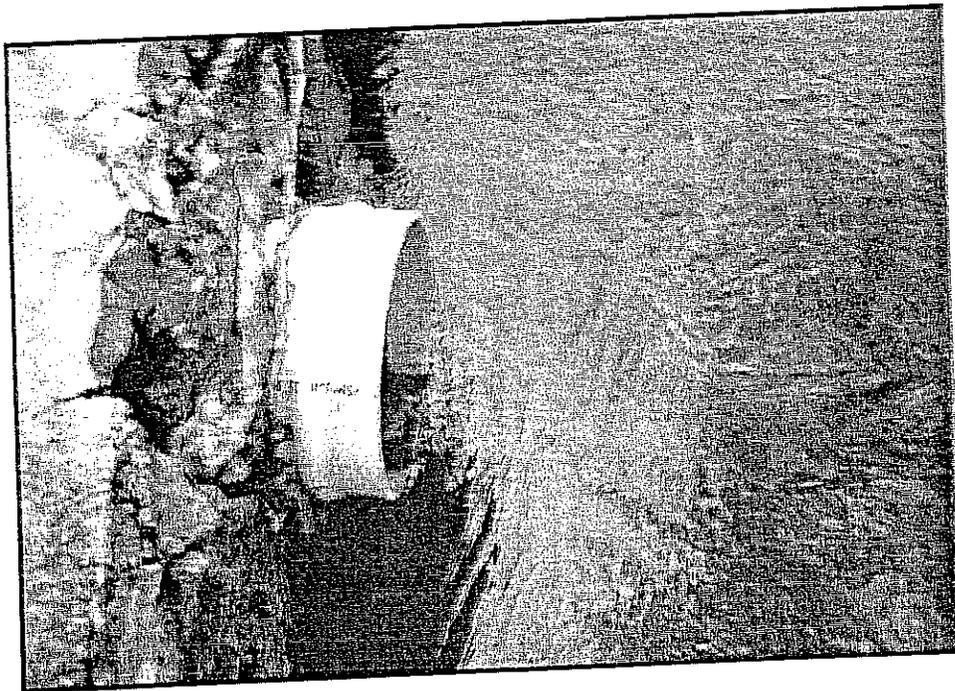
Pipe Size: _____ 12 _____ in Flow Estimate _____ 0.5 _____ gpm
Pipe Material/Condition _____ PVC/Good _____ Last Precipitation: _____ 10/30/96 _____
Clarity of Flow/Turbidity: _____ Clear _____

Comments: _____ Some iron bacteria was noticed on the bottom of the pipe. _____

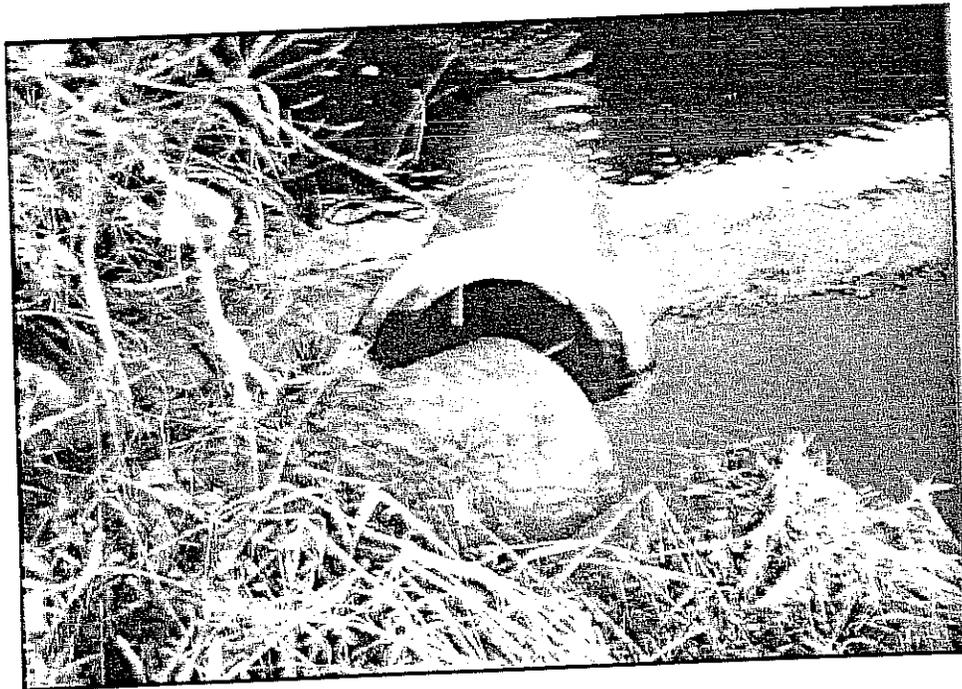
Pipe Size:	12	in	Flow Estimate:	Stagnant	gpm
Pipe Material/Condition:	RCP/Poor		Last Precipitation:	10/30/96	
			Clarity of Flow/Turbidity:	Clear

Comments: Sample was taken from inside the submerged pipe.

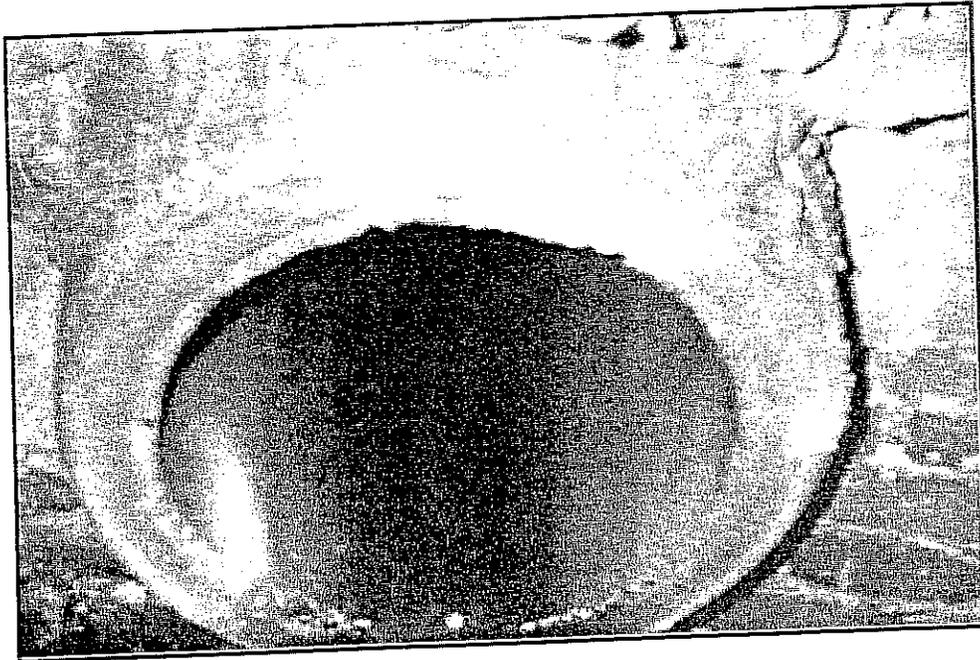
Pipe Size: 12 in.
Pipe Material/Condition: RCP/Fair
Flow Estimate: Dry gpm
Last Precipitation: 9/29/96
Clarity of Flow/Turbidity: NA

Comments: Visually clear water was observed infiltrating into the manhole from holes in the bricks.

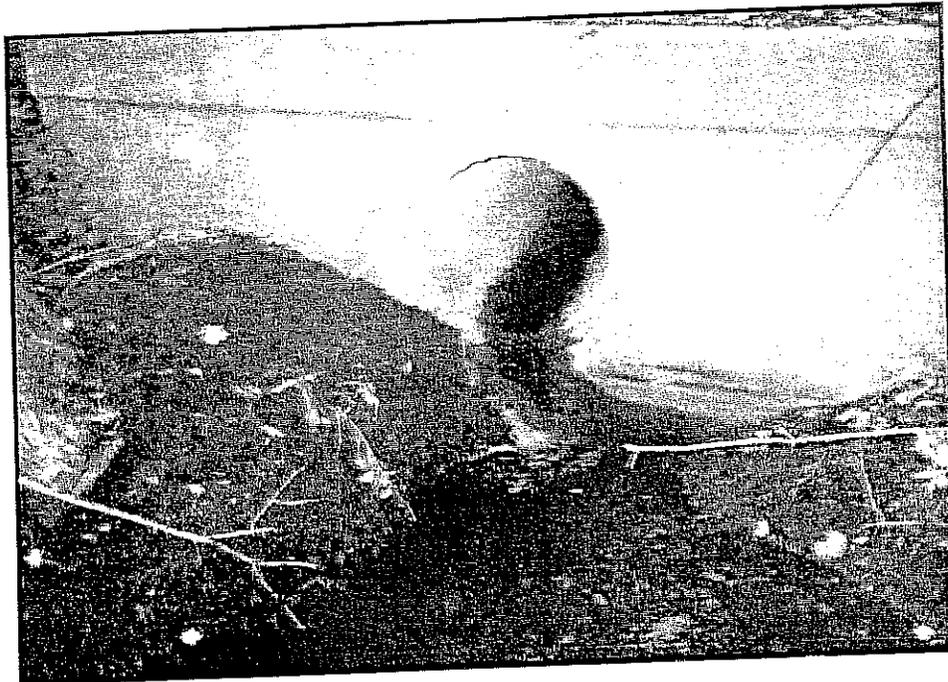
Pipe Size: 30 in. Flow Estimate: 0.2 gpm
Pipe Material/Condition: RCP/Good Last Precipitation: 9/29/96
Clarity of Flow/Turbidity: Clear

Comments: Some foam was located at the outfall.

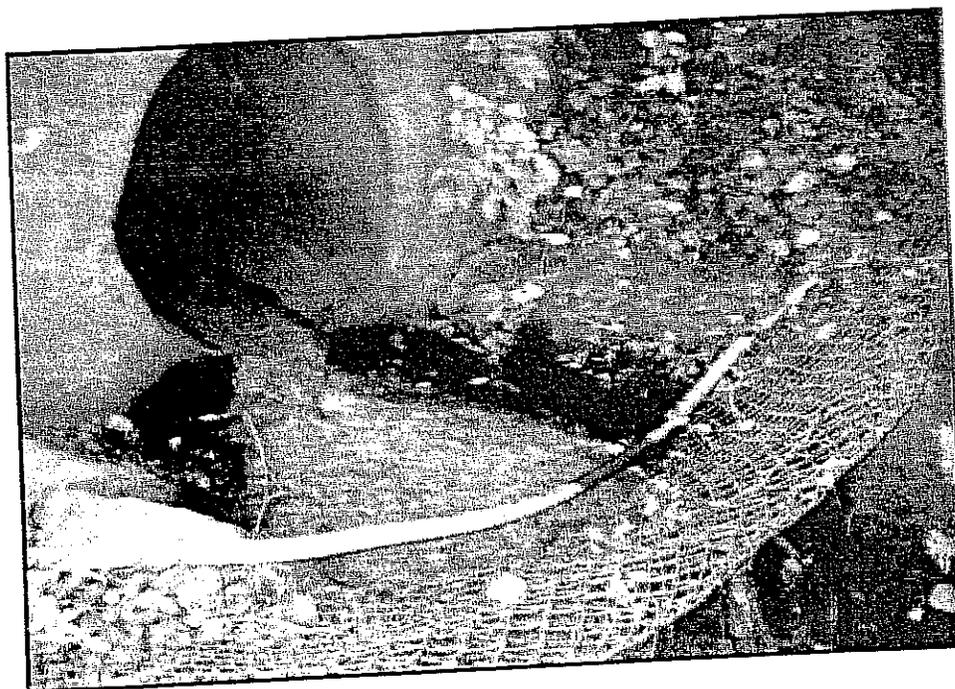
Figure 3.70

A sample was taken from this discharge on October 2, 1996 at 1:15 p.m. An approximate flow of 30 gpm of clear water was observed. BETA also observed iron bacteria flocculent in the pipe and on the stones of the outfall. The laboratory results revealed the following:

Pipe Size: 48 in Flow Estimate: 25 gpm
Pipe Material/Condition: Concrete/Good Last Precipitation: 10/9/96
Clarity of Flow/Turbidity: Clear

Comments: Iron bacteria was observed in the pipe and on the stones of the outfall.
