# Rehabilitation of Central Avenue / Elliot Street Bridge

October 29, 2015

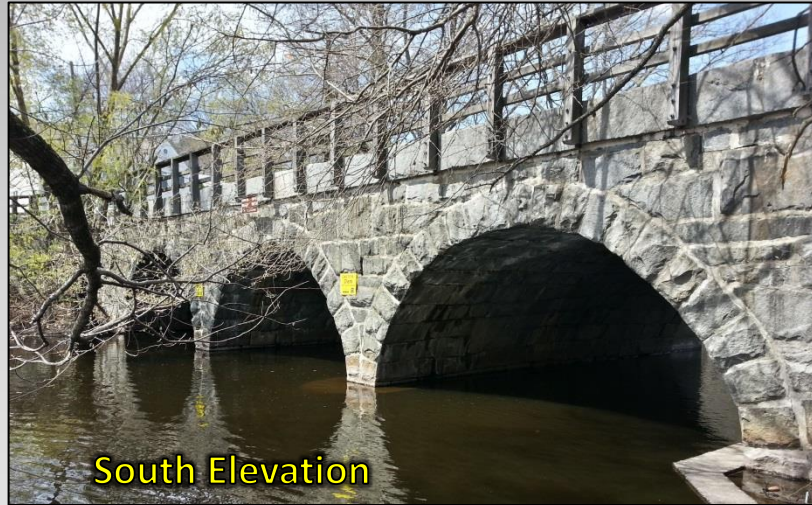
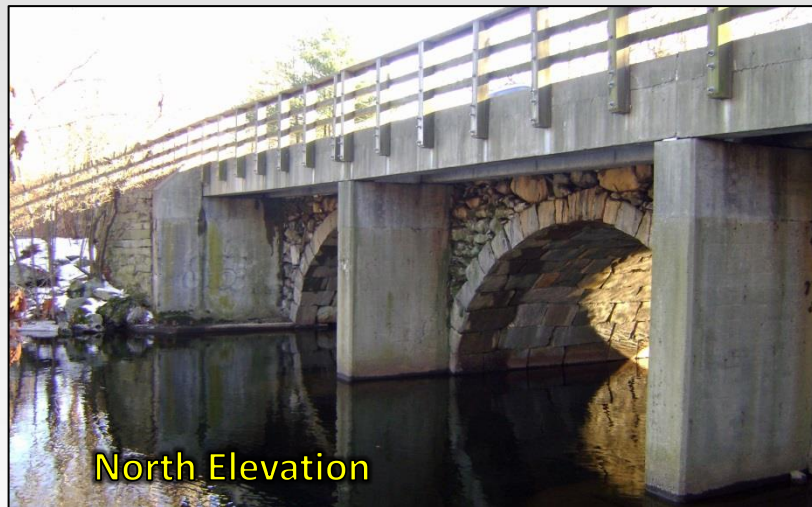
## Cook's Bridge

- Newton Upper Falls Historic District Contributing Element
- Unknown Construction Date
- 1844: First Repair Records
- 1897: Widened from 25 ft to 40 ft
- 1970: North Sidewalk and Piers
- 1991: Roadway & Sidewalk Replaced, South Sidewalk Added

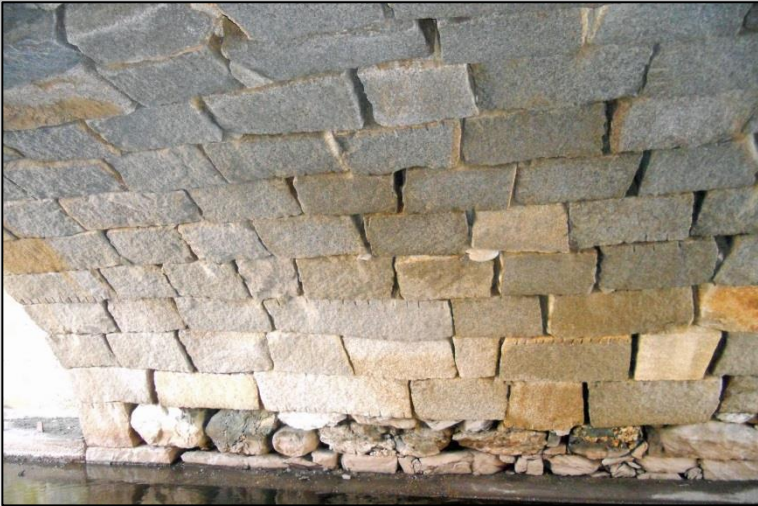
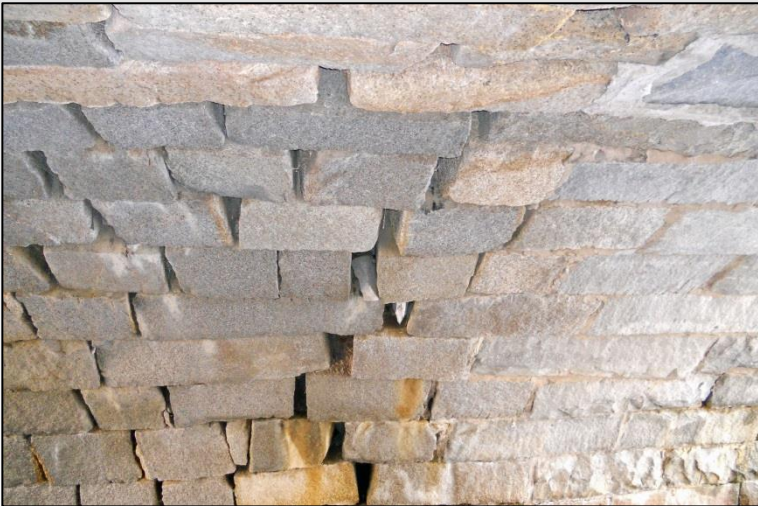
## Arch Barrel

- Deteriorated Stones along Spring Line
- Movement of Stones
- Large Gaps Between Stones
- Main Stones Fallen Out
- Reduced Load Capacity by MassDOT

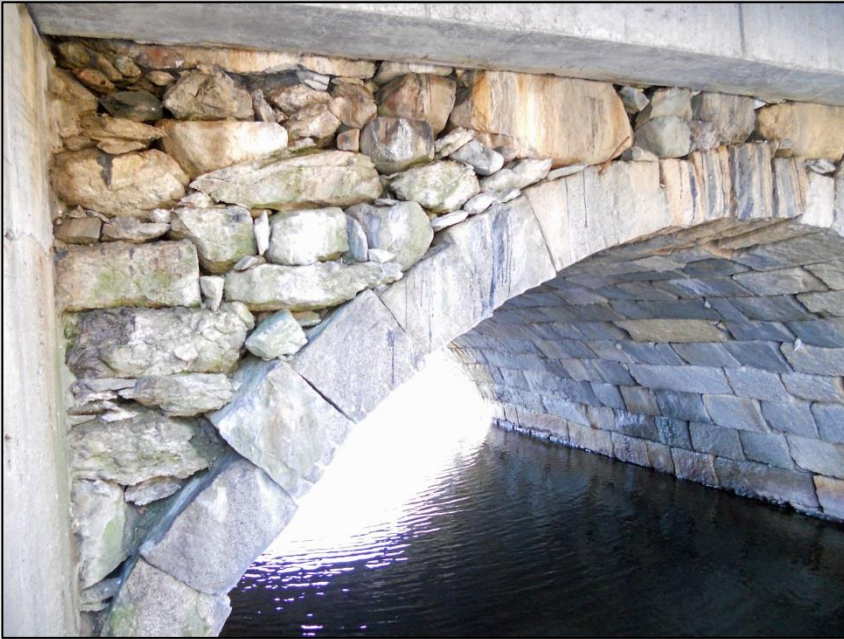
## North Spandrel Wall

- Loose Stones Throughout
- Moveable by Hand
- Large Voids Behind Stones
- Soft/Breakable Stones

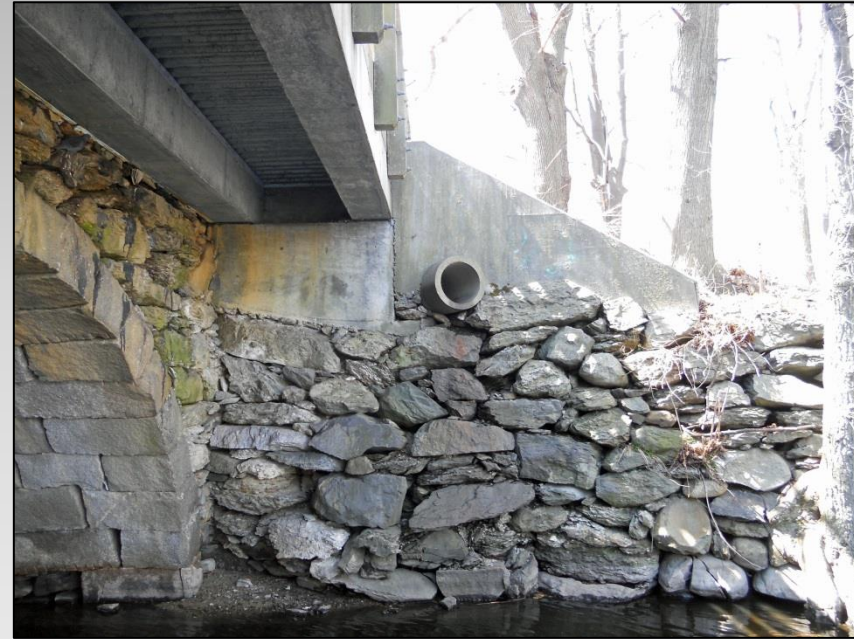
- Bulging Stone Wall
- Increased Fill and Loads from Sidewalk

## Northwest Wingwall

- Replace Wall
- Concrete Wall with Stone Veneer
- Reuse Original Stones

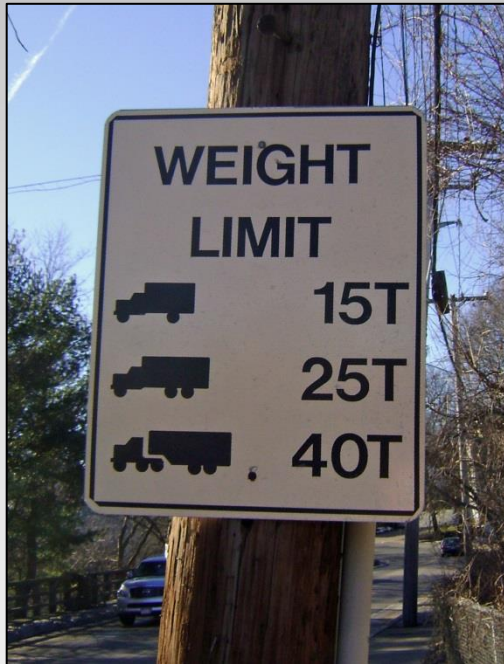
## Project Goals

- Restore Load Capacity
- Stop Movement of Stones
- Repair Voids
- Stop Water Infiltration/Loss of Fill
- Long Term Fix (75+ Year Service Life)
- Comply with Section 106 of Historic Preservation Act

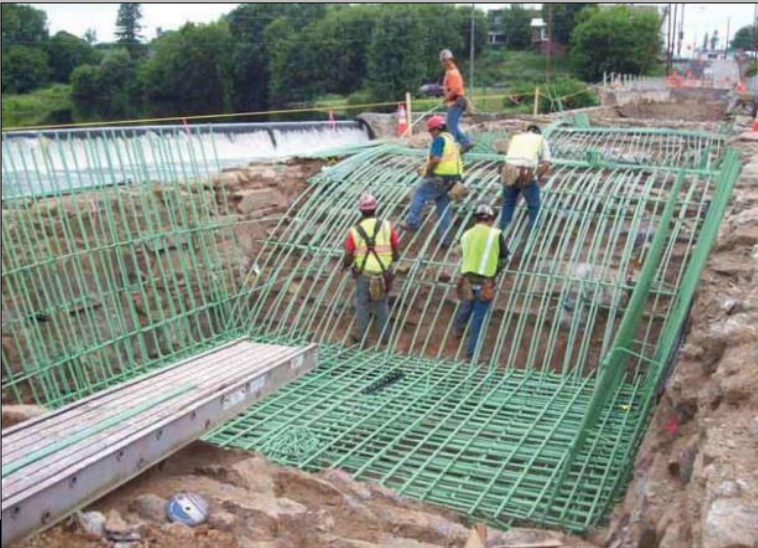
## Concrete Arch Saddle

- Remove Gravel Fill and Replace with Reinforced Concrete
- Remove North Spandrel Wall / Reuse Stones as Veneer

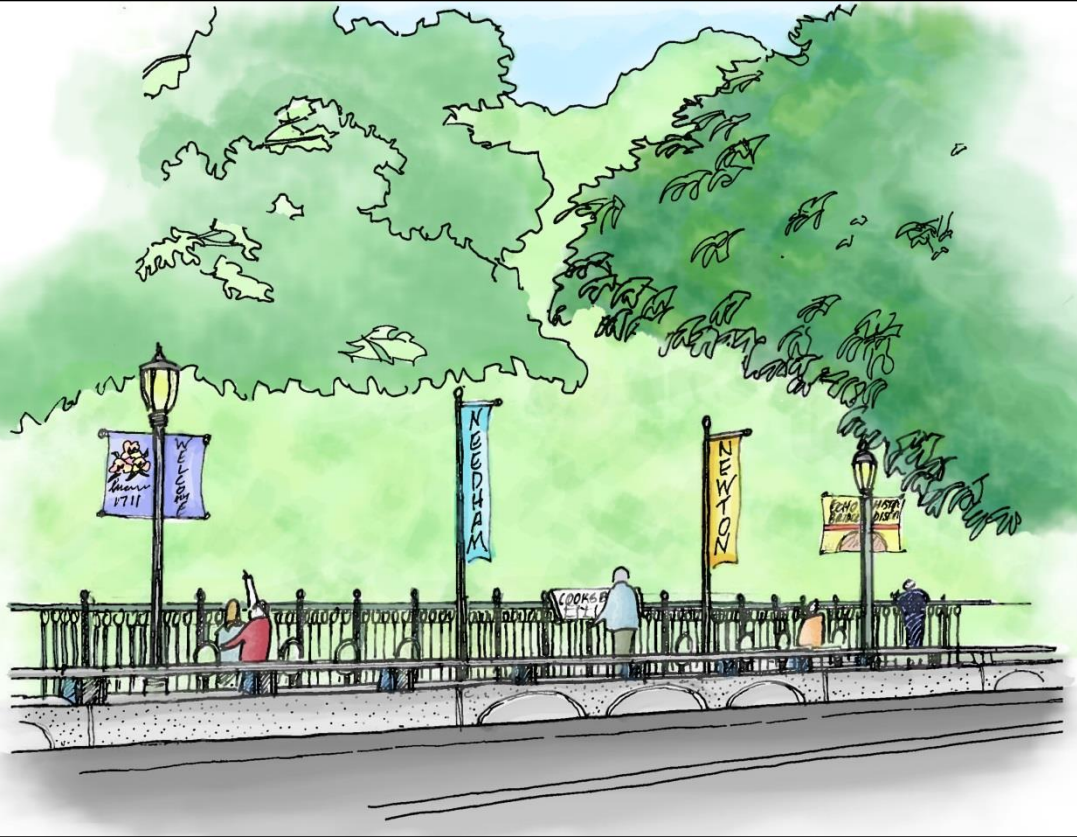
## Pedestrian Amenities

- Wider Sidewalks
- Ornamental Railings
- Vehicle Railing at Curb
- Benches
- Ornamental Lighting
- Banners
- Interpretive Panel
- Removal of Aerial Wires

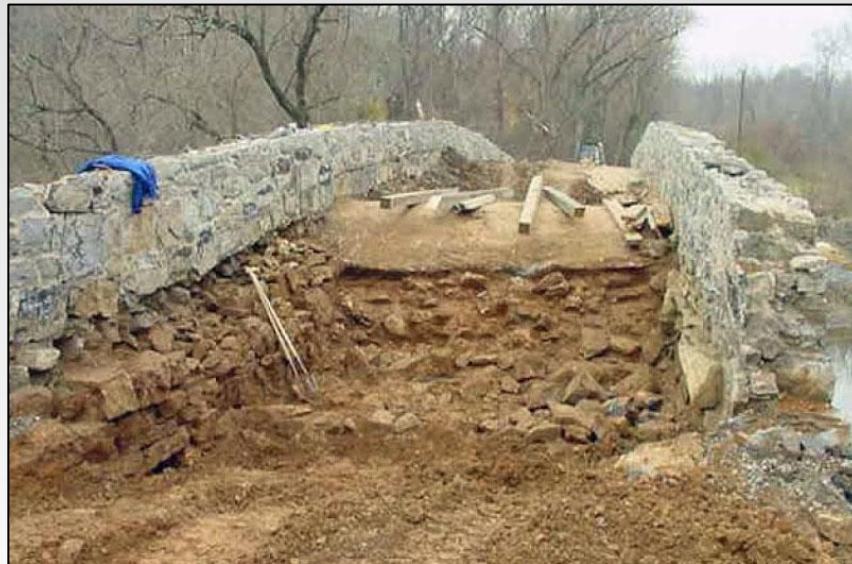
## Stone Arch Bridge

- Fill Cannot be Excavated Vertically Without Temporary Sheet piling
  - Not Possible on Bridge
- Unloaded Sections of Arch would be Vulnerable to Unbalanced Loads and Vibrations from Traffic
