PRELIMINARY HIGH-RISK CROSSWALK LOCATIONS

Prepared By:
Greenman-Pedersen, Inc.
181 Ballardvale Street, Suite 202
Wilmington, MA 01887

Prepared for:
Town of Needham, MA; Engineering Department
500 Dedham Avenue
Needham, MA 02492

October 2018

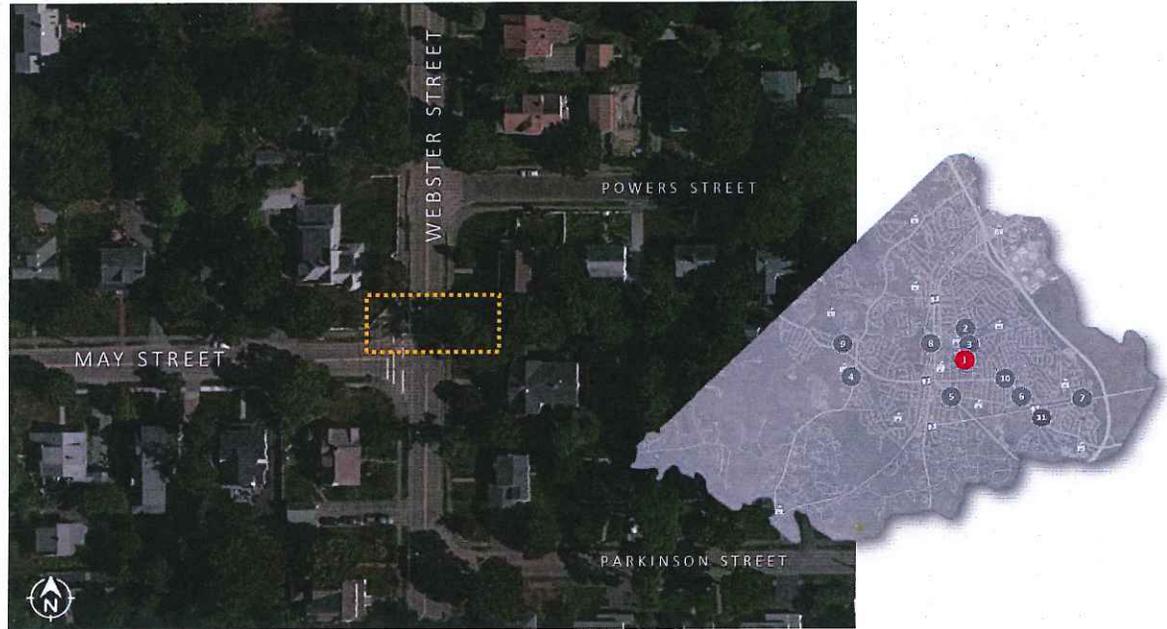
WEBSTER STREET AT MAY STREET

Existing Conditions: The standard marked crosswalk on Webster Street is uncontrolled. No pedestrian crossing signage is present. May Street is STOP sign controlled. Vehicles approaching the intersection from the west on May Street may experience poor sight lines due to the tree line in both directions on Webster Street, the utility pole in the northwest corner of the intersection as well as the vegetation and fence in the northwest corner. Ramps are lacking detectable warning panels and accessibility should be examined for conformance to current ADA standards. Street lighting is present in the northwest and southwest corners of the intersection. Pedestrians crossing Webster Street from the east may be difficult to see at night. Existing curb radii at the intersection are large resulting in a long crossing distance along May Street.

Initial Recommendations: To supplement the marked crosswalk along Webster Street, a pedestrian actuated Rectangular Rapid Flashing Beacon (RRFB) system (S1-1/W16-7P assembly) shall be installed as well as advanced pedestrian crossing signage. Crosswalk markings shall be refreshed.

Further Recommendations may be suggested at this intersection as part of the Full Pedestrian Safety Audit, including tightened curb radii at May Street to reduce crossing distance and increase pedestrian visibility. Additional street lighting may be warranted especially in the southeast corner of the intersection.

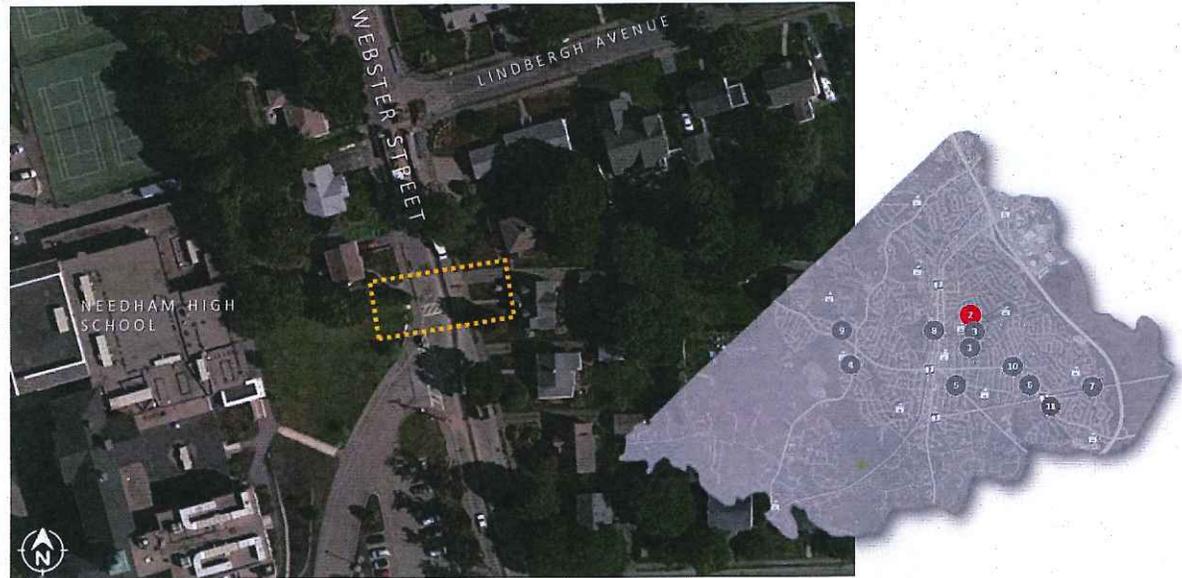
WEBSTER STREET AT HIGH SCHOOL (NORTH)

Existing Conditions: The existing marked hatch (zebra) style crosswalk along Webster Street is uncontrolled. There is existing pedestrian crossing signage with flashing LED border lighting; however, the sign is flashing continuously rather than only when pedestrians are present. This could result in drivers becoming accustomed to the sign and not reacting accordingly when a pedestrian is actually in the crosswalk. Advanced pedestrian crossing signage (S1-1/W16-9P assembly) is present for both directions on Webster Street. Sight lines are adequate for both approaches. Ramps are lacking detectable warning panels and accessibility should be examined for conformance to current ADA standards. Street lighting exists just north of the crosswalk on the western side of Webster Street, but no lighting is available for the eastern side.

Initial Recommendations: To supplement the marked crosswalk along Webster Street, the LED flashing sign should be replaced by a pedestrian actuated RRFB system (W1-1/W16-7P assembly). New, updated advanced pedestrian crossing signage shall be installed as well. Crosswalk markings shall be refreshed.

Further recommendations may be suggested at this location as part of the Full Pedestrian Safety Audit, including geometric modifications to the high school entrance to reduce the curb radii in the northwest corner of the intersection which currently may facilitate high speed turning movements. Curb extensions may also be explored to reduce the crossing distance along Webster Street and potentially slow down vehicle speeds. Additional street lighting may be warranted for the eastern ramp of the Webster Street crossing.

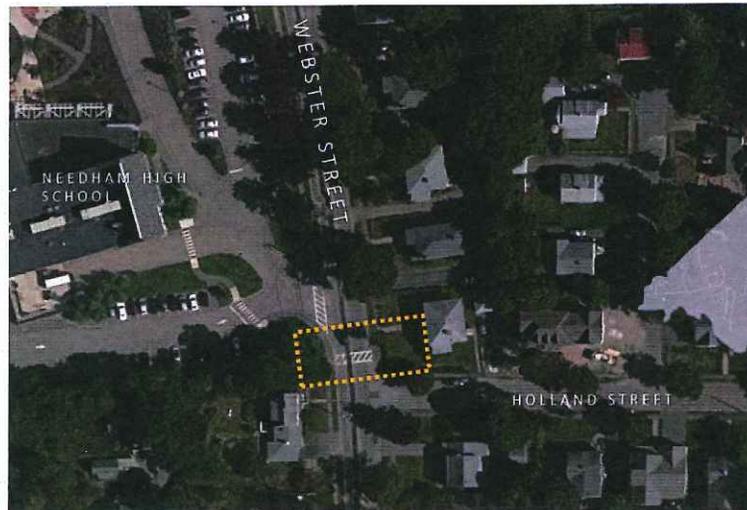
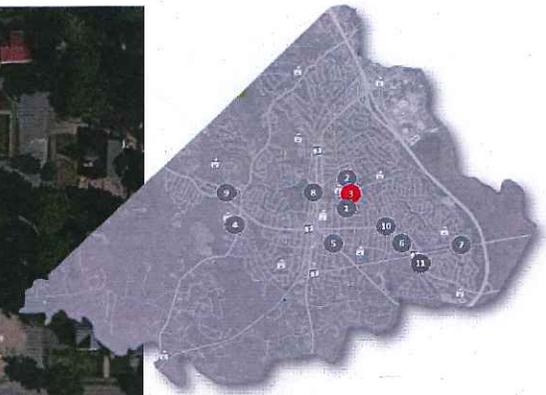
WEBSTER STREET AT HIGH SCHOOL (SOUTH)

Existing Conditions: The existing marked hatch (zebra) style crosswalk along Webster Street is uncontrolled. There is existing pedestrian crossing signage with flashing LED border lighting; however, the sign is flashing continuously rather than only when a pedestrian is present. This could result in drivers becoming accustomed to the sign and not reacting accordingly when a pedestrian is actually in the crosswalk. There is no advanced warning signage. The crosswalk is located just south of the Needham High School exit in which many vehicles exit right towards the crosswalk and sight lines may be compromised due to the existing geometry and tree line. Street lighting is present on the west side of Webster Street approximately 85 feet north of the crosswalk and 55 feet south of the crosswalk which may not be adequate to efficiently light the crossing. Ramps are lacking detectable warning panels and accessibility should be examined for conformance to current ADA standards.

Initial Recommendations: To supplement the marked crosswalk along Webster Street, the LED flashing sign should be replaced by a pedestrian actuated RRFB system (W1-1/W16-7P assembly). New, updated advanced pedestrian crossing signage shall be installed as well. Crosswalk markings shall be refreshed.

Further recommendations may be suggested at this location as part of the Full Pedestrian Safety Audit, including geometric modifications to the high school exit to reduce the curb radii in the southwest corner of the intersection which currently may facilitate high speed turning movements. Curb extensions may also be explored to reduce the crossing distance along Webster Street and potentially slow down vehicle speeds. Existing street lighting may require modification to more efficiently light the crosswalk on the western side of Webster Street and additional street lighting may be warranted for the eastern ramp of the Webster Street crossing.

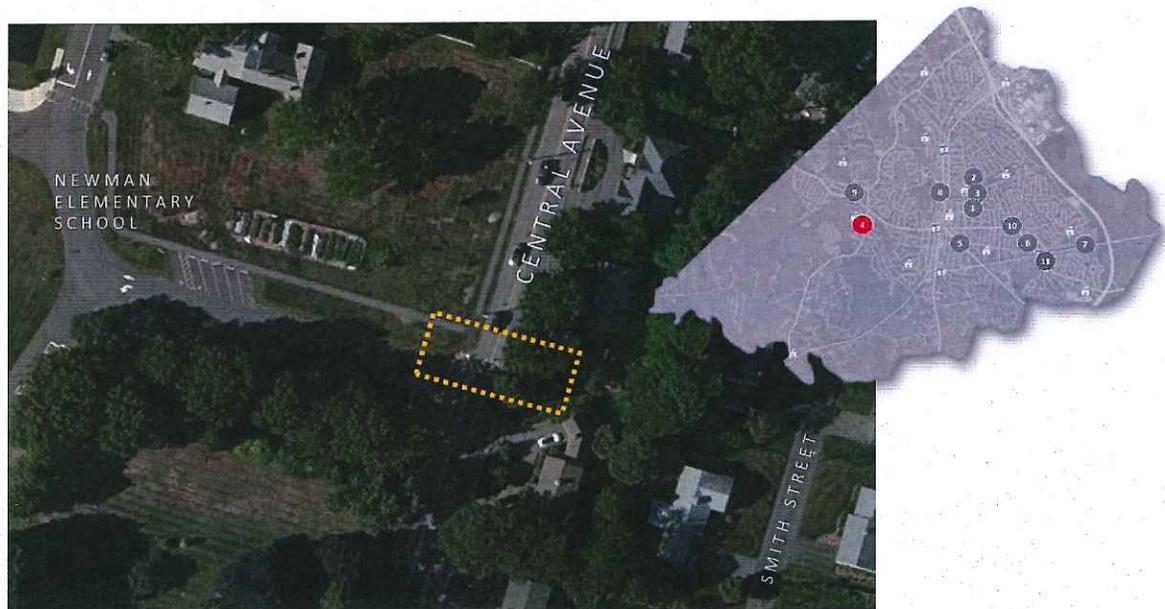
CENTRAL AVENUE AT NEWMAN ELEMENTARY SCHOOL

Existing Conditions: The existing marked hatch (zebra) style crosswalk along Central Avenue is uncontrolled. There is existing pedestrian crossing signage at the crosswalk (S1-1/W16-7P assembly) for both approach lanes. Advanced warning school crossing signs (S1-1/W16-9P assembly) are present for both approaches on Central Avenue. 'SCHOOL' pavement marking stencils and school flashing beacon signs are available in advance of the crosswalk per Massachusetts School Zone requirements. An in-road pedestrian crossing sign (R1-6) is located within the crosswalk across Central Avenue. Street lighting is present on the west side of Webster Street approximately 35 feet north of the crosswalk and 85 feet south of the crosswalk which may not be adequate to efficiently light the crossing. The eastern ramp on Central Avenue is lacking a detectable warning panel and accessibility should be examined for conformance to current ADA standards.

Initial Recommendations: To supplement the marked crosswalk along Central Avenue, a pedestrian actuated RRFB system (S1-1/W16-7P assembly) shall be installed as well as new advanced pedestrian crossing signage and updated school zone flashing beacons. Crosswalk markings and 'SCHOOL' stencils should be refreshed.

Further recommendations may be suggested as part of the Full Pedestrian Safety Audit, such as curb extensions along Central Avenue or possible tightening curb radii for the school entrance location. Additional lighting may be required along the eastern side of Central Avenue to efficiently light the crosswalk.

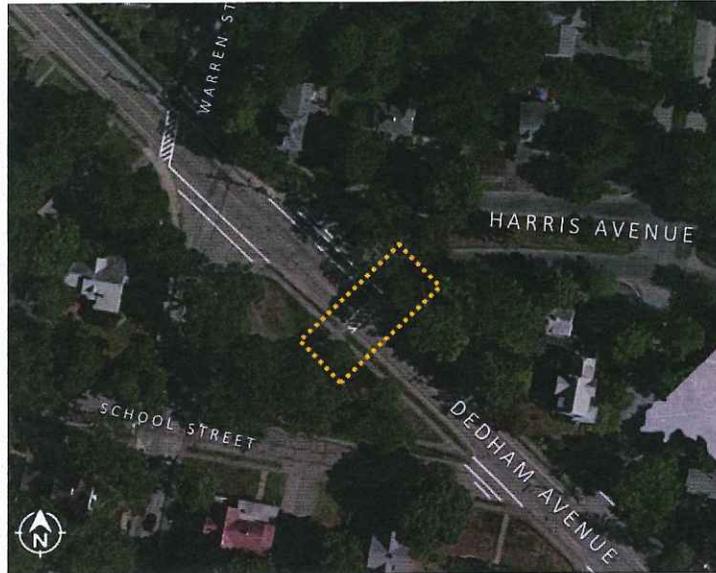
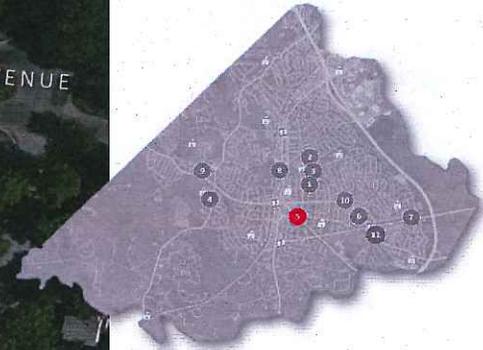
DEDHAM AVENUE AT HARRIS AVENUE

Existing Conditions: The existing marked hatch (zebra) style crosswalk along Dedham Avenue is uncontrolled. There is existing pedestrian crossing signage at the crosswalk (S1-1/W16-7P assembly) for the northbound approach only. Advanced warning school crossing signs (S1-1/W16-9P assembly) are present for both approaches on Dedham Avenue. An in-road pedestrian crossing sign (R1-6) is located within the crosswalk across Dedham Avenue. Street lighting is present on the east side of Dedham Avenue approximately 20 feet south of the crosswalk. There is no lighting on the western side of Dedham Avenue. Ramps servicing the Dedham Avenue crosswalk are non-ADA compliant. Given the complexity of the intersection and the adjacent intersection with Warren Street to the north, pedestrian safety is compromised.

Initial Recommendations: To supplement the marked crosswalk along Dedham Avenue, a pedestrian actuated RRF system (S1-1/W16-7P assembly) shall be installed as well as advanced pedestrian crossing signage. Crosswalk markings should be refreshed, and accessible ramps shall be installed.

Further recommendations may be suggested at this location as part of the Full Pedestrian Safety Audit, including geometric modifications to the entire intersection to reduce complexity and prioritize pedestrian safety along this high-volume roadway. This may include the elimination or consolidation of the two marked crosswalks along Dedham Avenue in the vicinity of the Harris Avenue/Warren Street intersections. Additional lighting may be required along the western side of Dedham Avenue to efficiently light the crosswalk.

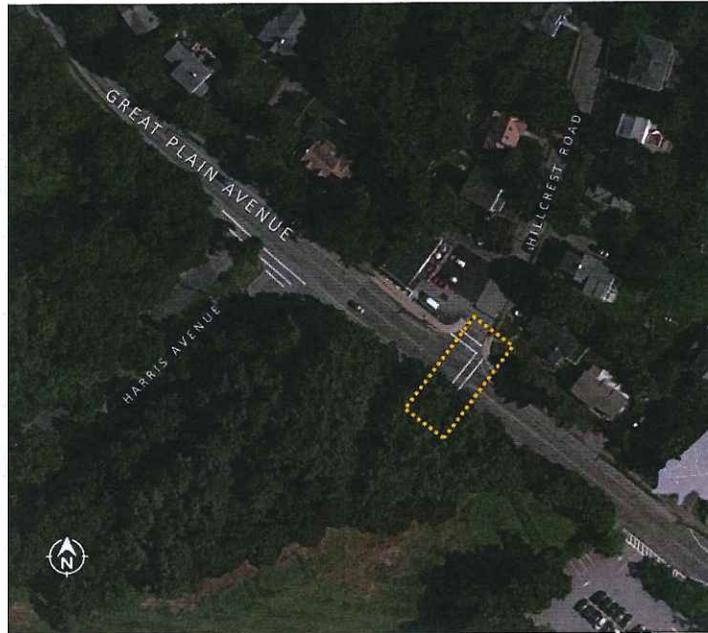
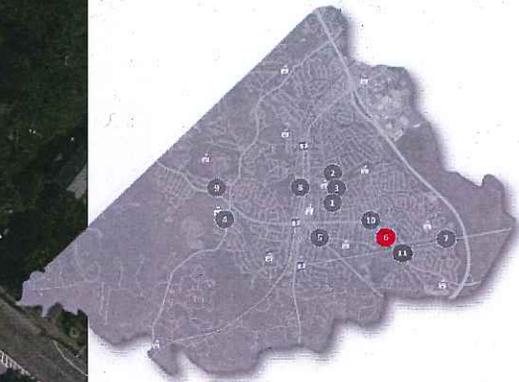
GREAT PLAIN AVENUE AT HILLCREST ROAD

Existing Conditions: The existing standard style crosswalk along Great Plain Avenue is uncontrolled. There is existing pedestrian crossing signage at the crosswalk (S1-1/W16-7P assembly) for both approach lanes. Advanced warning pedestrian crossing signs are not present for either approach. An in-road pedestrian crossing sign (R1-6) is located within the crosswalk across Great Plain Avenue. Street lighting is present on the east side of Great Plain Avenue approximately 55 feet north of the crosswalk and 85 feet south of the crosswalk which may not be adequate to efficiently light the crossing. No street lighting is present on the western side of Great Plain Avenue. Ramps are lacking detectable warning panels and accessibility should be examined for conformance to current ADA standards.

Initial Recommendations: To supplement the marked crosswalk along Great Plain Avenue, a pedestrian actuated RRF system (W1-1/W16-7P assembly) shall be installed as well as advanced pedestrian crossing signage. Crosswalk markings shall be refreshed with high visibility paint.

Further recommendations may be suggested at this location as part of the Full Pedestrian Safety Audit, including curb extensions to reduce the crossing distance along Great Plain Avenue and potentially slow down vehicle speeds. Existing street lighting may require modification to more efficiently light the crosswalk.

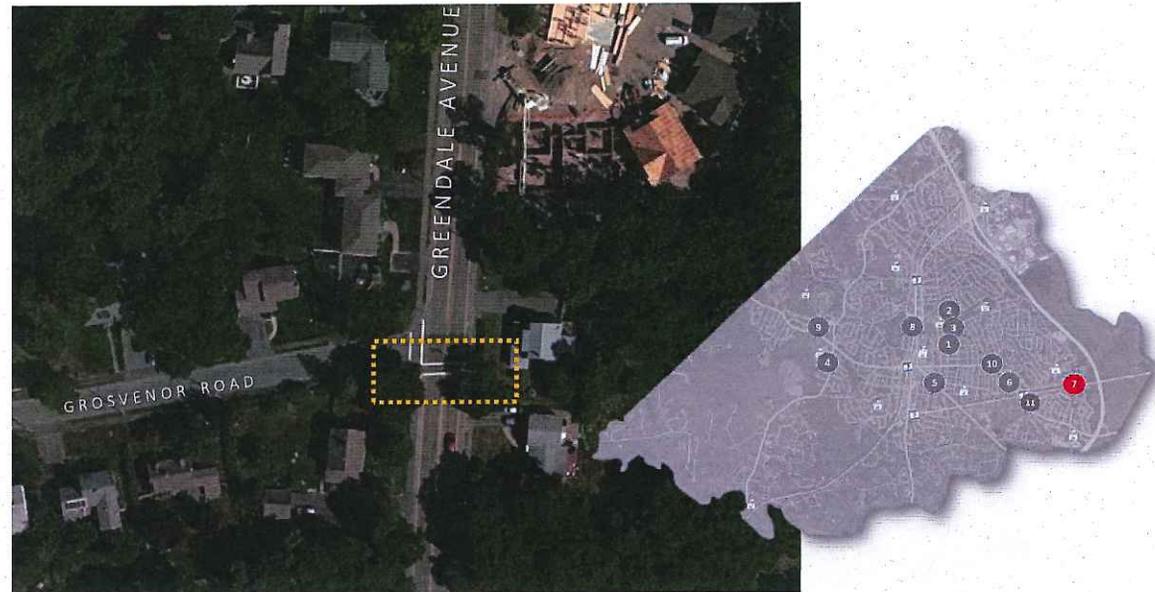
GREENDALE AVENUE AT GROSVENOR ROAD

Existing Conditions: The existing standard marked crosswalk along Greendale Avenue is uncontrolled. There is existing pedestrian crossing signage at the crosswalk (S1-1/W16-7P assembly) for both approach lanes. Advanced warning school crossing signs (S1-1 assembly) are present for both approaches on Greendale Avenue. An in-road pedestrian crossing sign (R1-6) is located within the crosswalk across Greendale Avenue. Street lighting is present on the east side of Greendale Avenue directly above the crosswalk which may not effectively light the crossing. There is no lighting on the western side of Greendale Avenue. Both ramps servicing the crosswalk lack detectable warning panels and are inaccessible.

Initial Recommendations: Given the moderately paced speed limit (40 mph) within the vicinity of this crosswalk, a RRFB may not be appropriate. Due primarily to the speed along Greendale Avenue, the town is currently installing a Pedestrian Hybrid Beacon (HAWK Signal) to the north at the intersection of Greendale Avenue and Bird Street/Rybury Hillway. In addition, the crosswalk just south of this location at Greendale Avenue and Intervale Road should also be considered. Further analysis is recommended to determine if both crosswalks are needed, or if they could be consolidated to a more defined location with the inclusion of an additional Hawk Signal.

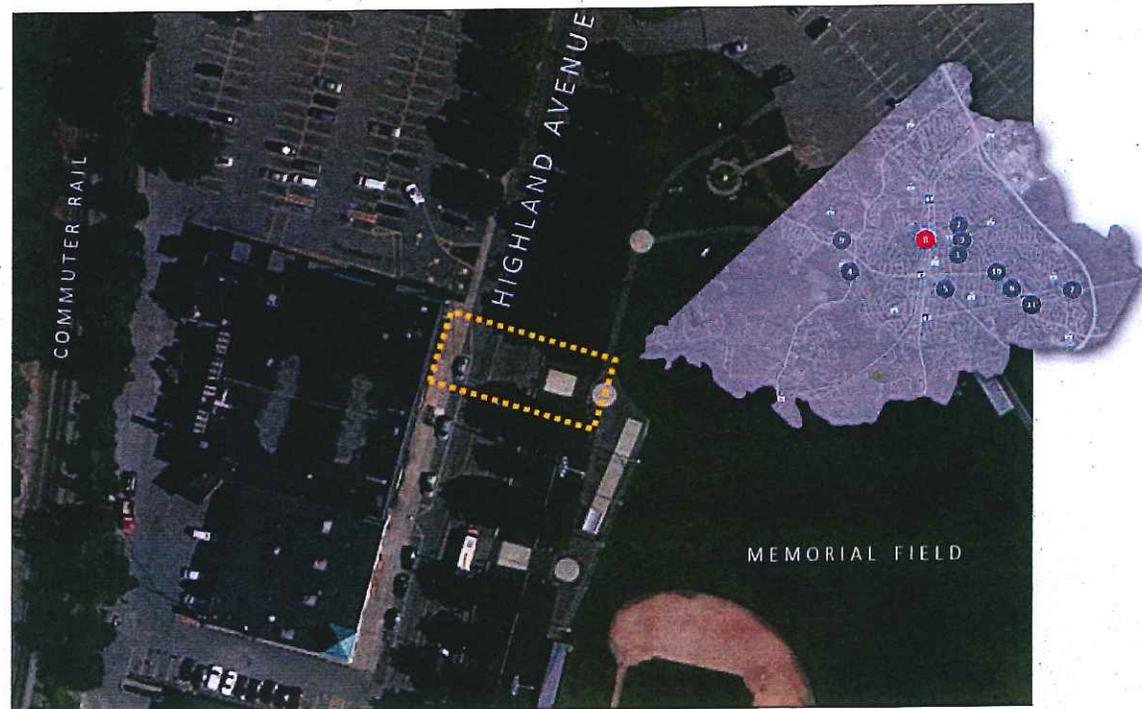
HIGHLAND AVENUE AT MEMORIAL FIELD STAIRS (NORTH)

Existing Conditions: There is currently no crosswalk located at this location; however, according to community surveys and preliminary observations, students regularly cross Highland Avenue in this area. The roadway in this vicinity is very wide with on-street parking on the west side contributing to the poor visibility of pedestrians.

Initial Recommendations: Pedestrian counts must be conducted at this location, but should the counts reveal a heavy demand for a marked crosswalk, the Town should consider the installation of a pedestrian actuated RRFB in conjunction with a high visibility crosswalk treatment at this location.

Further Recommendations: Providing a crossing location at this site will require extensive ADA compliancy in regard to the staircase. Accessible ramps will be required at the crossing and perhaps a pedestrian refuge island or curb extensions should be explored to reduce the crossing distance. Any treatments will likely result in the loss of a few parking spaces.

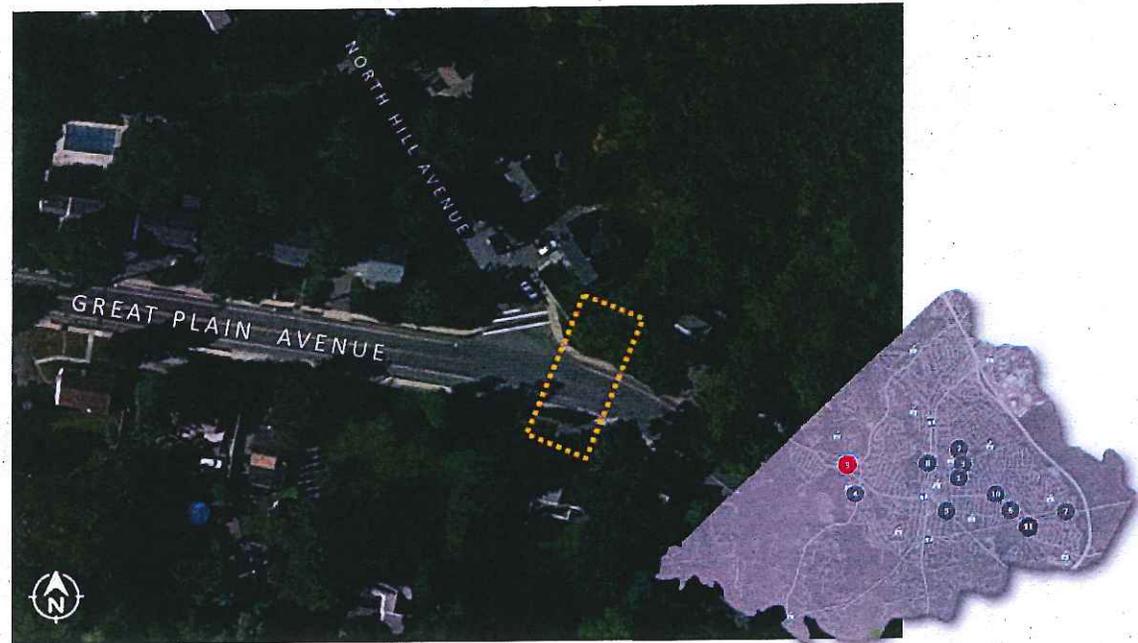
GREAT PLAIN AVENUE AT NORTH HILL AVENUE

Existing Conditions: The existing marked hatch (zebra) style crosswalk along Great Plain Avenue is uncontrolled. There is existing pedestrian crossing signage at the crosswalk (W1-1/W16-7P/R1-6 assembly) for both approaches, however, signage is placed after the crosswalk rather leading before and adjacent. Advanced warning school crossing signs (W1-1/W16-9P assembly) are present for both approaches on Great Plain Avenue. Street lighting is present on the northern side of Great Plain Avenue only, approximately 75 feet east and west of the crosswalk. Despite the curvature in the roadway, sight lines do not appear to be problematic.

Initial Recommendations: To supplement the marked crosswalk along Great Plain Avenue, a pedestrian actuated RRFB system (S1-1/W16-7P assembly) shall be installed as well as new advanced pedestrian crossing signage. Crosswalk markings should be refreshed.

Further recommendations as part of the Full Pedestrian Safety Audit may include accessible ramps with detectable warning panels. Street lighting may require modification to efficiently service the crosswalk. Curb extensions may also be explored to reduce pedestrian crossing distance and potentially slow down vehicle speeds.

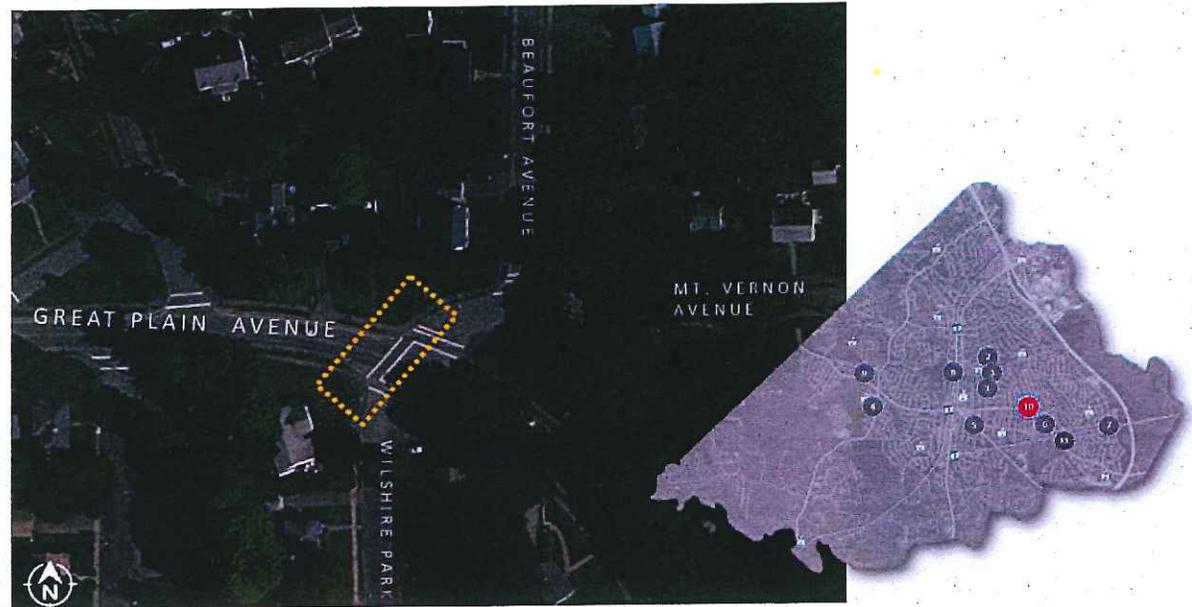
GREAT PLAIN AVENUE AT WILSHIRE PARK / BEAUFORT AVENUE

Existing Conditions: The existing standard crosswalk along Great Plain Avenue is uncontrolled. There is existing pedestrian crossing signage at the crosswalk (W1-1/W16-7P/R1-6 assembly) for both approaches, however, signage is placed after the crosswalk rather than before and adjacent along the northwest approach. Advanced warning school crossing signs (S1-1 assembly) are present for both approaches on Great Plain Avenue. There is no street lighting on Great Plain Avenue in the vicinity of the crosswalk. The curvature in the roadway creates sight line issues specifically for vehicles traveling northwest on Great Plain Avenue. Ramps are lacking detectable warning panels and accessibility should be examined for conformance to current ADA standards.

Initial Recommendations: To supplement the marked crosswalk along Great Plain Avenue, a pedestrian actuated RRFBS system (S1-1/W16-7P assembly) shall be installed as well as new advanced pedestrian crossing signage. Crosswalk markings should be refreshed.

Further recommendations may be suggested at this location as part of the Full Pedestrian Safety Audit to address sight line concerns and may require relocation of the crosswalk to the west near the intersection of Great Plain Avenue at Plymouth Road. Street lighting may require modification to efficiently service the crosswalk. Ramp accessibility shall be examined and addressed.

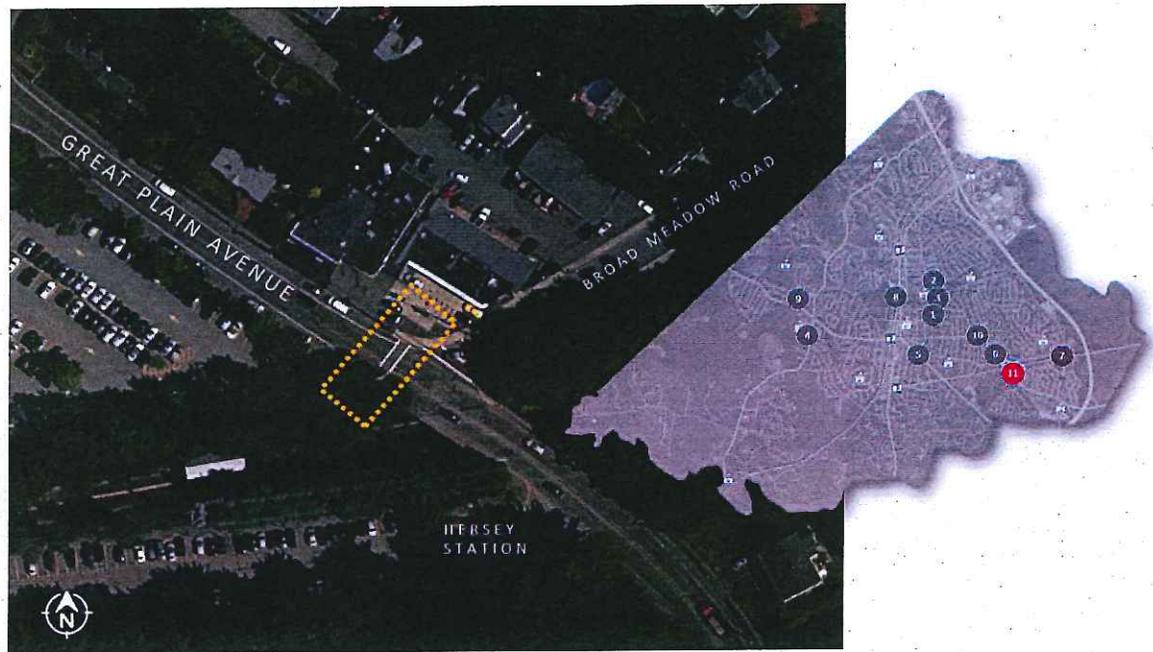
GREAT PLAIN AVENUE AT BROAD MEADOW ROAD

Existing Conditions: The existing standard style crosswalk along Great Plain Avenue is uncontrolled. There is existing pedestrian crossing signage at the crosswalk (S1-1/W16-7P assembly) for both approach lanes. Advanced warning pedestrian crossing signs are present for both approaches. An in-road pedestrian crossing sign (R1-6) is located within the crosswalk across Great Plain Avenue. Street lighting is present on the east side of Great Plain Avenue approximately 55 feet north of the crosswalk and 85 feet south of the crosswalk which may not be adequate to efficiently light the crossing. No street lighting is present on the western side of Great Plain Avenue. Ramps are lacking detectable warning panels and accessibility should be examined for conformance to current ADA standards.

Initial Recommendations: To supplement the marked crosswalk along Great Plain Avenue, a pedestrian actuated RRFBS system (W1-1/W16-7P assembly) shall be installed as well as advanced pedestrian crossing signage. Crosswalk markings shall be refreshed with high visibility paint.

Further recommendations may be suggested at this location as part of the Full Pedestrian Safety Audit, including curb extensions to reduce the crossing distance along Great Plain Avenue and potentially slow down vehicle speeds. Existing street lighting may require modification to more efficiently light the crosswalk.
