Town of Needham, Massachusetts  
**Spring 2013 Townwide  
Inflow & Infiltration Study**  
*Final Submission: March 2017*

## Phase I Report

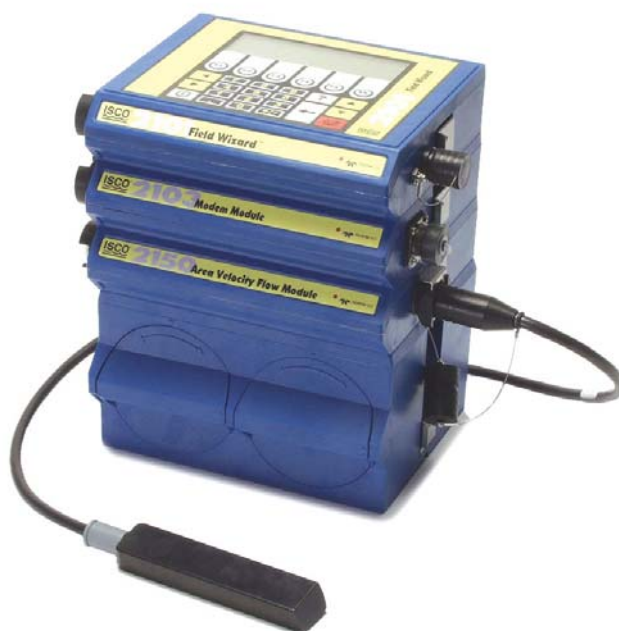
Photo above shows a typical flow module grouping that includes Isco's 2101 Field Wizard™, a 2103 Modem Module, a 2150 Area Velocity Module, and a 2191 Battery Module.

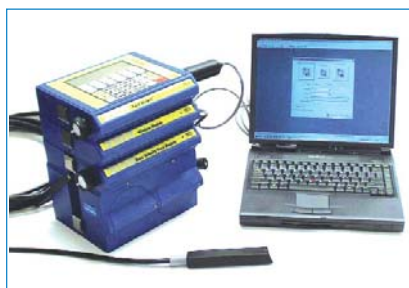
2100 Series modems are set up using Isco Flowlink® Data Management Software

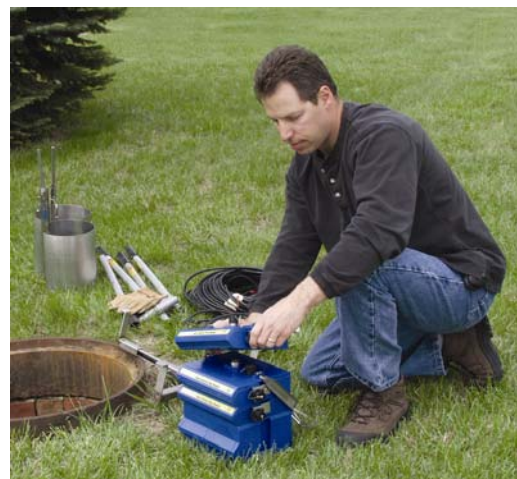
*Above left: Additional modules can be added for redundant or multi-stream measuring (Isco 2110 Ultrasonic Module shown). Right: Optional mounting rings provide quick, secure sensor installation in round pipes from 6 to 80 inches (150 to 2000 mm).*

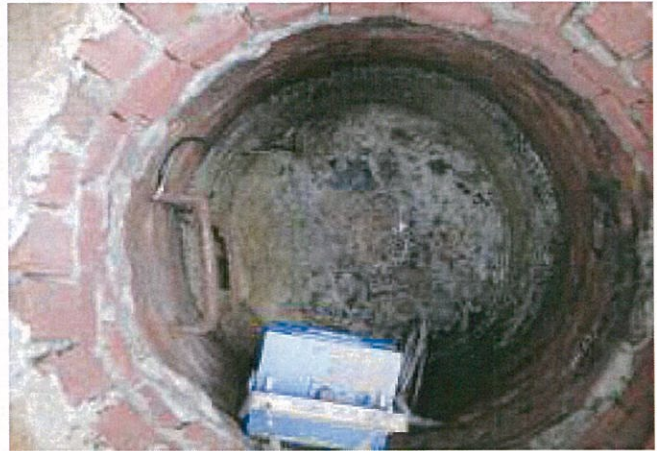
**Top View**

No picture available - pipe was surcharged
