# Walker Pond Improvements

Latest news and bulletin updates

## Overall Project Status Review

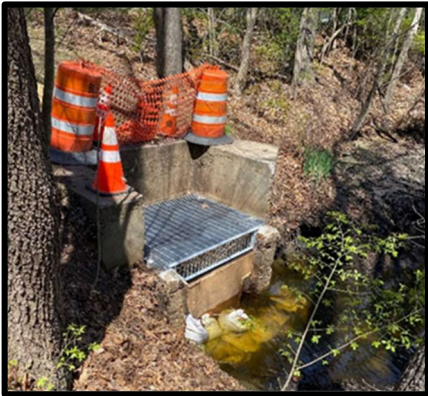
During 2022 the Walker Pond experienced rapidly dropping water levels. A DPW crew was dispatched to assess the possible cause. In addition to severe environmental conditions, the overflow structure was inspected and revealed significant deterioration beyond typical maintenance. The full assessment of the structure verified the need for full structure replacement.

The outlet structure at the intersection of Walker Lane and Central Ave was designed and constructed as a poured-in-place concrete device and has been in operation since the mid-1990's. The stop logs utilized for controlling the pond elevation and structural integrity has weakened and is no longer functioning as designed. The DPW fortified the structure temporarily with a fabricated steel plating however water is still able to release necessitating the sandbags currently in place until a permanent solution could be developed and implemented.

Replacement presents an opportunity to increase functionality of the asset through installation of a more modern structure that is easy, safe, and cost-effective to maintain and is fabricated in a way to allow discharge sampling from the pond. The sampling capability will support monitoring of pond health while still functioning as a control asset for water levels. The project team is finalizing a design or procurement of a pre-fabricated structure that takes into consideration longevity, operations and maintenance ease and safety.

A portion of the total funding request was earmarked for minor improvements to the outlet structure, including the overflow grate and wooden stop-log replacements. The increased scope of the necessary structure replacement will result in reallocation of budget resources for procurement, installation and construction activities, permitting and project management.

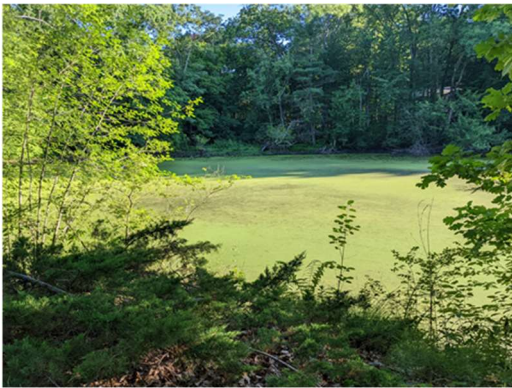
*Photo provided by Mark Ettinger on July 28, 2022.*

Another element to water quality is treatment. Pond treatment represents the process of biological oxidation of organic matter whether affected by natural or artificially accelerated transfer of oxygen. The report developed by ESS advised chemical treatments may improve the water quality and address observed algae and vegetated overgrowth.

Walker Pond was treated previously with positive results and has provided the community with years of pond usage and enjoyment. Given the current conditions and quality today, resuming a chemical treatment course remains a part of the Category II phase.
