Walker Pond Improvements

Walker Pond Management Plan

Prepared by: BETA GROUP, INC.

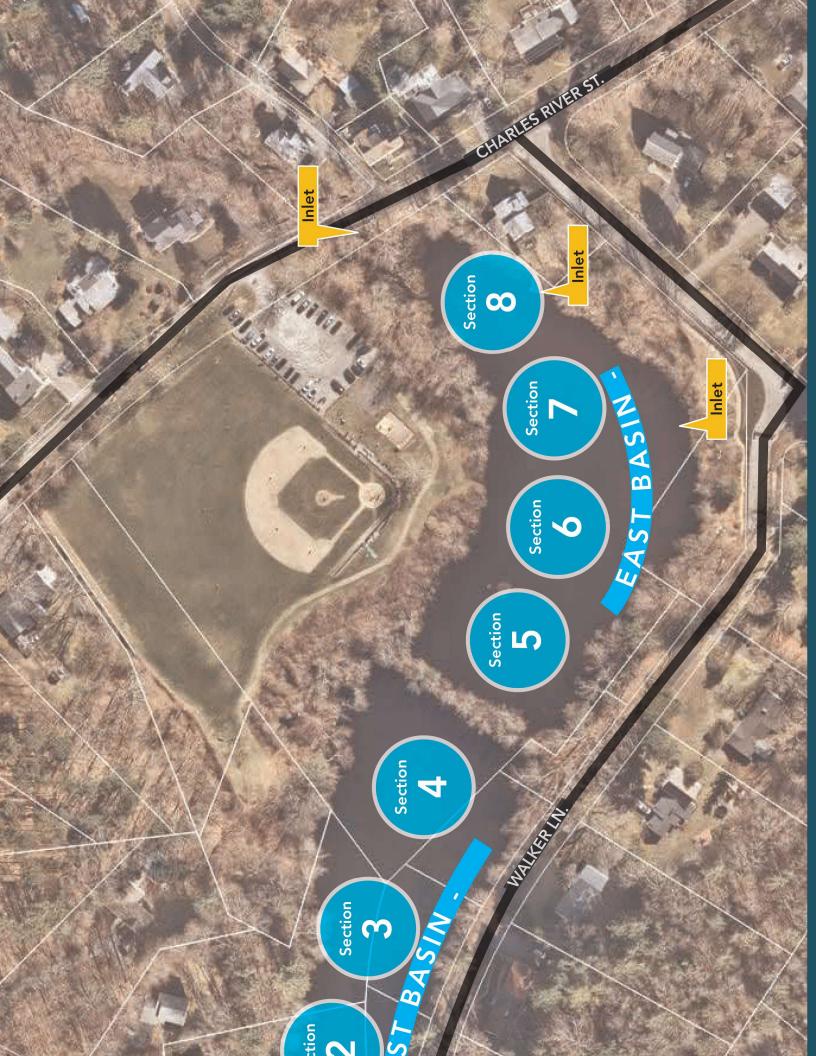
Figure 3-2: Soil Sampling Locations

included composite samples at sections 1, 3, 5, and 7, as well as grab samples at 3 inlet locations, which are identified in **Figure 3-2**. The fractionation provides data on the type of phosphorus found in the samples and how it is expected to interact with the water column in the Pond.

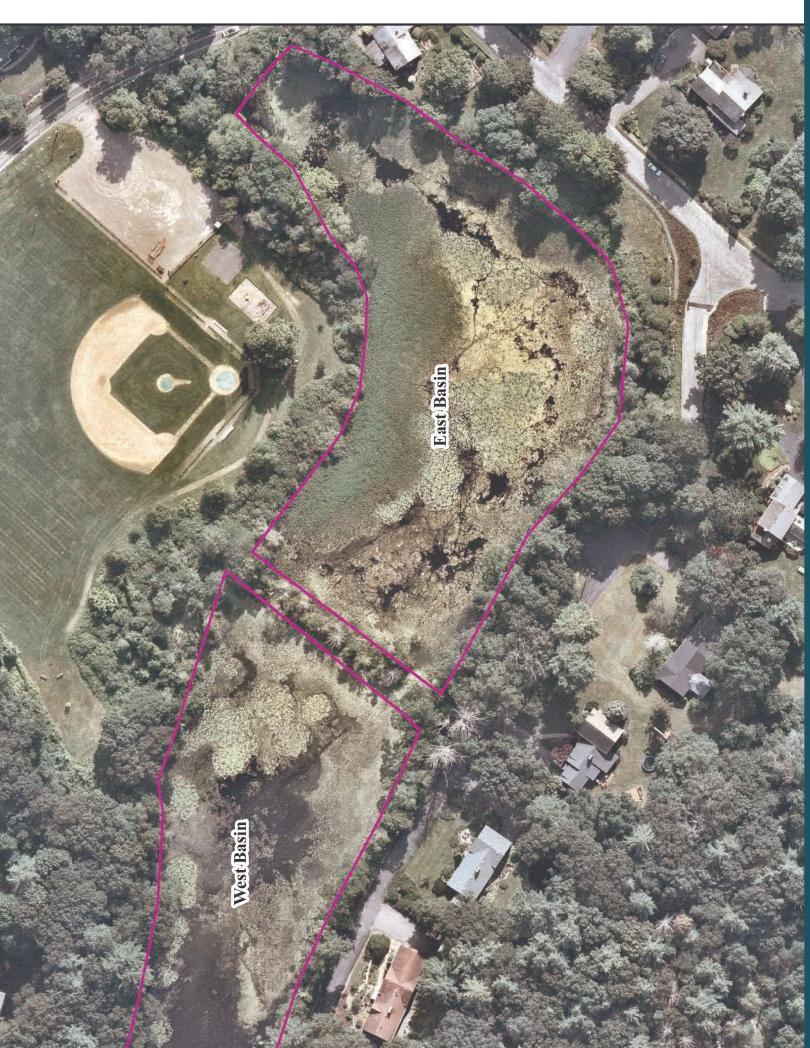
Figure 5-1: Vegetation Treatment Coverage Map

The currently proposed method for managing nuisance vegetation within the Pond is the use of herbicide. "Sonar" (fluridone) was recommended for use in Walker Pond due to the variety and density of nuisance vegetation. This formulation is designed to slowly break down vegetation by stripping away the plant's natural sun protection and allowing sunlight to gradually kill the plant. The advantage of this herbicide is that it can target a large variety of nuisance species at the same time while maintaining beneficial species that are resistant to the herbicide.
