# Walker Pond Improvements

## Phase II Walker Pond Improvements

### Walker Pond Treatments

### Walker Pond Outlet Structure

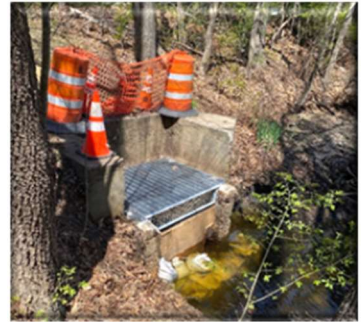
At the southwest corner of Walker Pond is an outlet structure designed to control the pond's water level. This structure, which allows overflow through a culvert beneath Central Avenue, was originally built with provisions for timber stop logs to adjust the weir flow elevation. The planned replacement outlet structure is designed with improvements for the following:

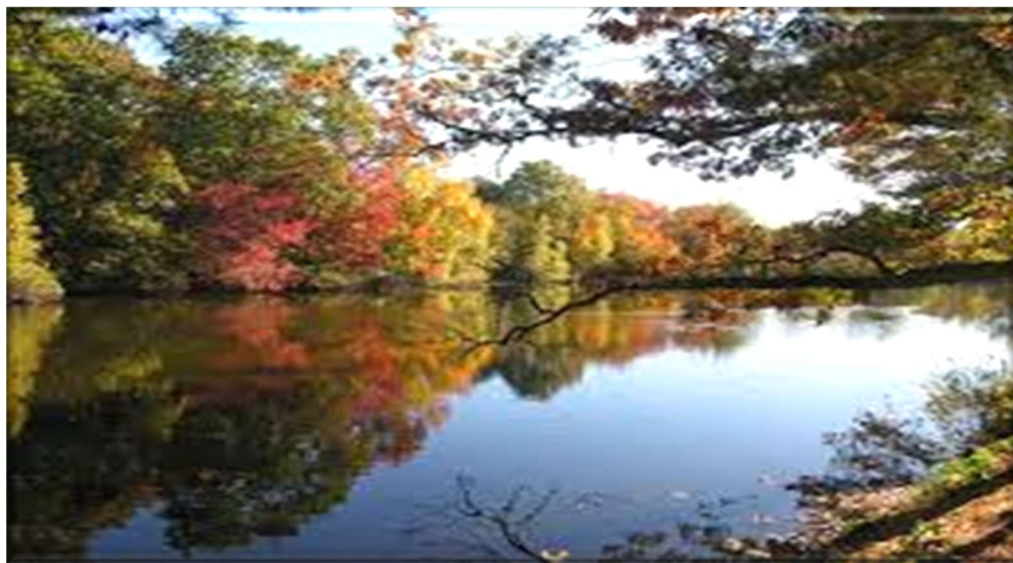
- Maintain desired pond elevation and provide ability for the Town to modify the elevation if needed for pond management
- Maintain discharge flow so not to exceed the capacity of existing downstream system and provide capability to pass the 100-yr storm
- Public safety improvements
- Ability to perform water quality sampling
- Longevity, operations and maintenance ease & safety

Additionally, an existing 12-inch pipe outfall at the northeast corner of the pond, near the intersection of Walker Lane and Russell Road, will be upgraded with the installation of a concrete headwall.

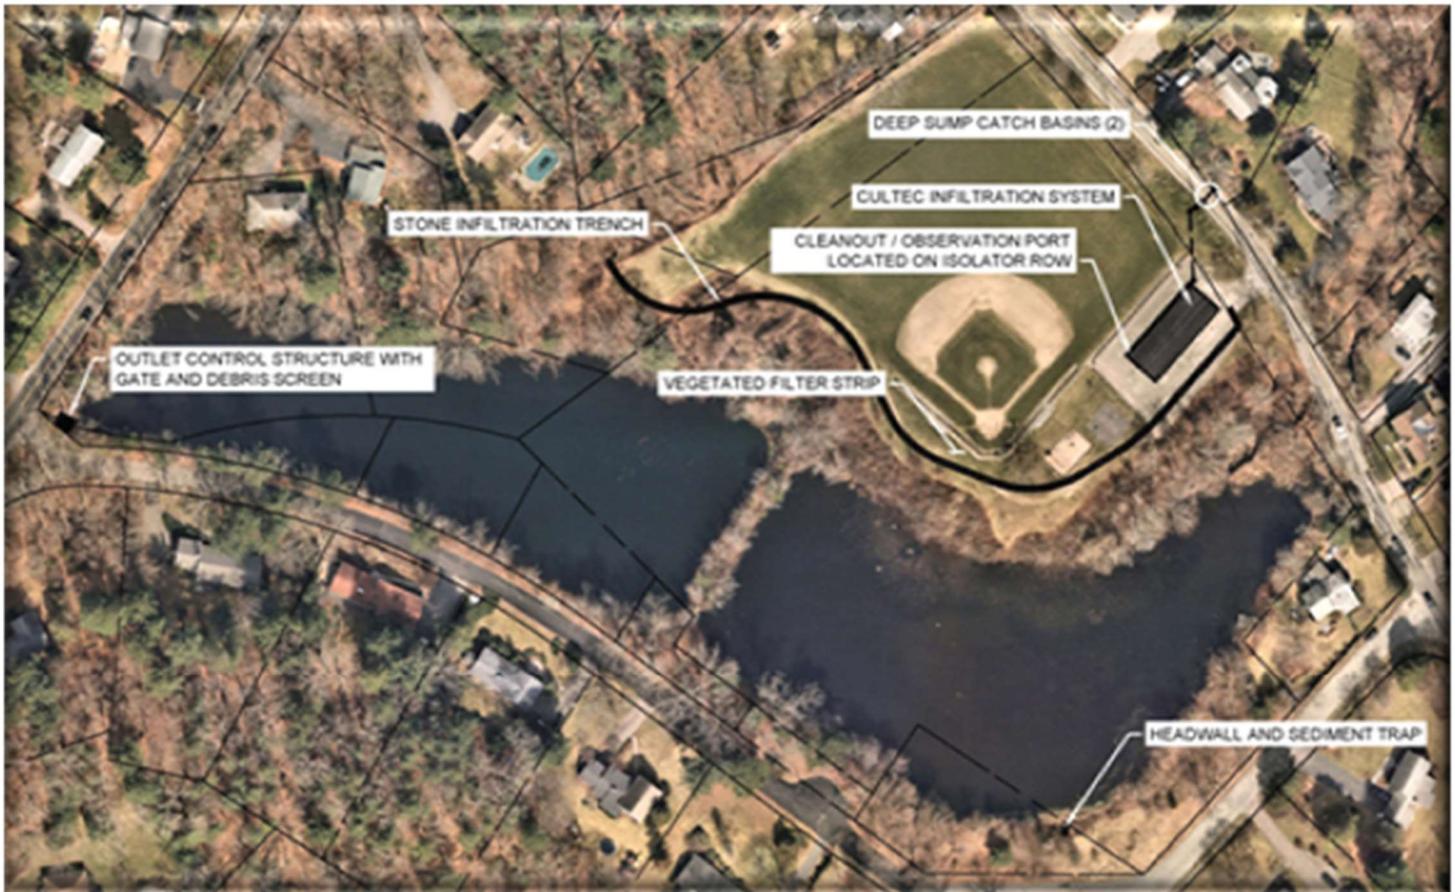
Based on aerial imagery of pond vegetation and on the ground observations, there is likely a significant contribution of nutrient and bacteria running from Walker Gordon Field, directly into the eastern basin of Walker Pond. This will be mitigated with installation of a perimeter infiltration trench to encourage infiltration of surface runoff from Walker Gordon Field before it discharges overland into the Pond.

A second BMP is proposed to treat runoff from 15 ± acres of developed land upgradient of the park and includes installing a subsurface infiltration system under the gravel parking lot.
