Stormwater Drain Outfall Inspection Report

PROJECT NAME: Needham, MA Stormwater Investigation

Section III. Dry Weather Sampling Procedure and Results, and Drainage Area Descriptions

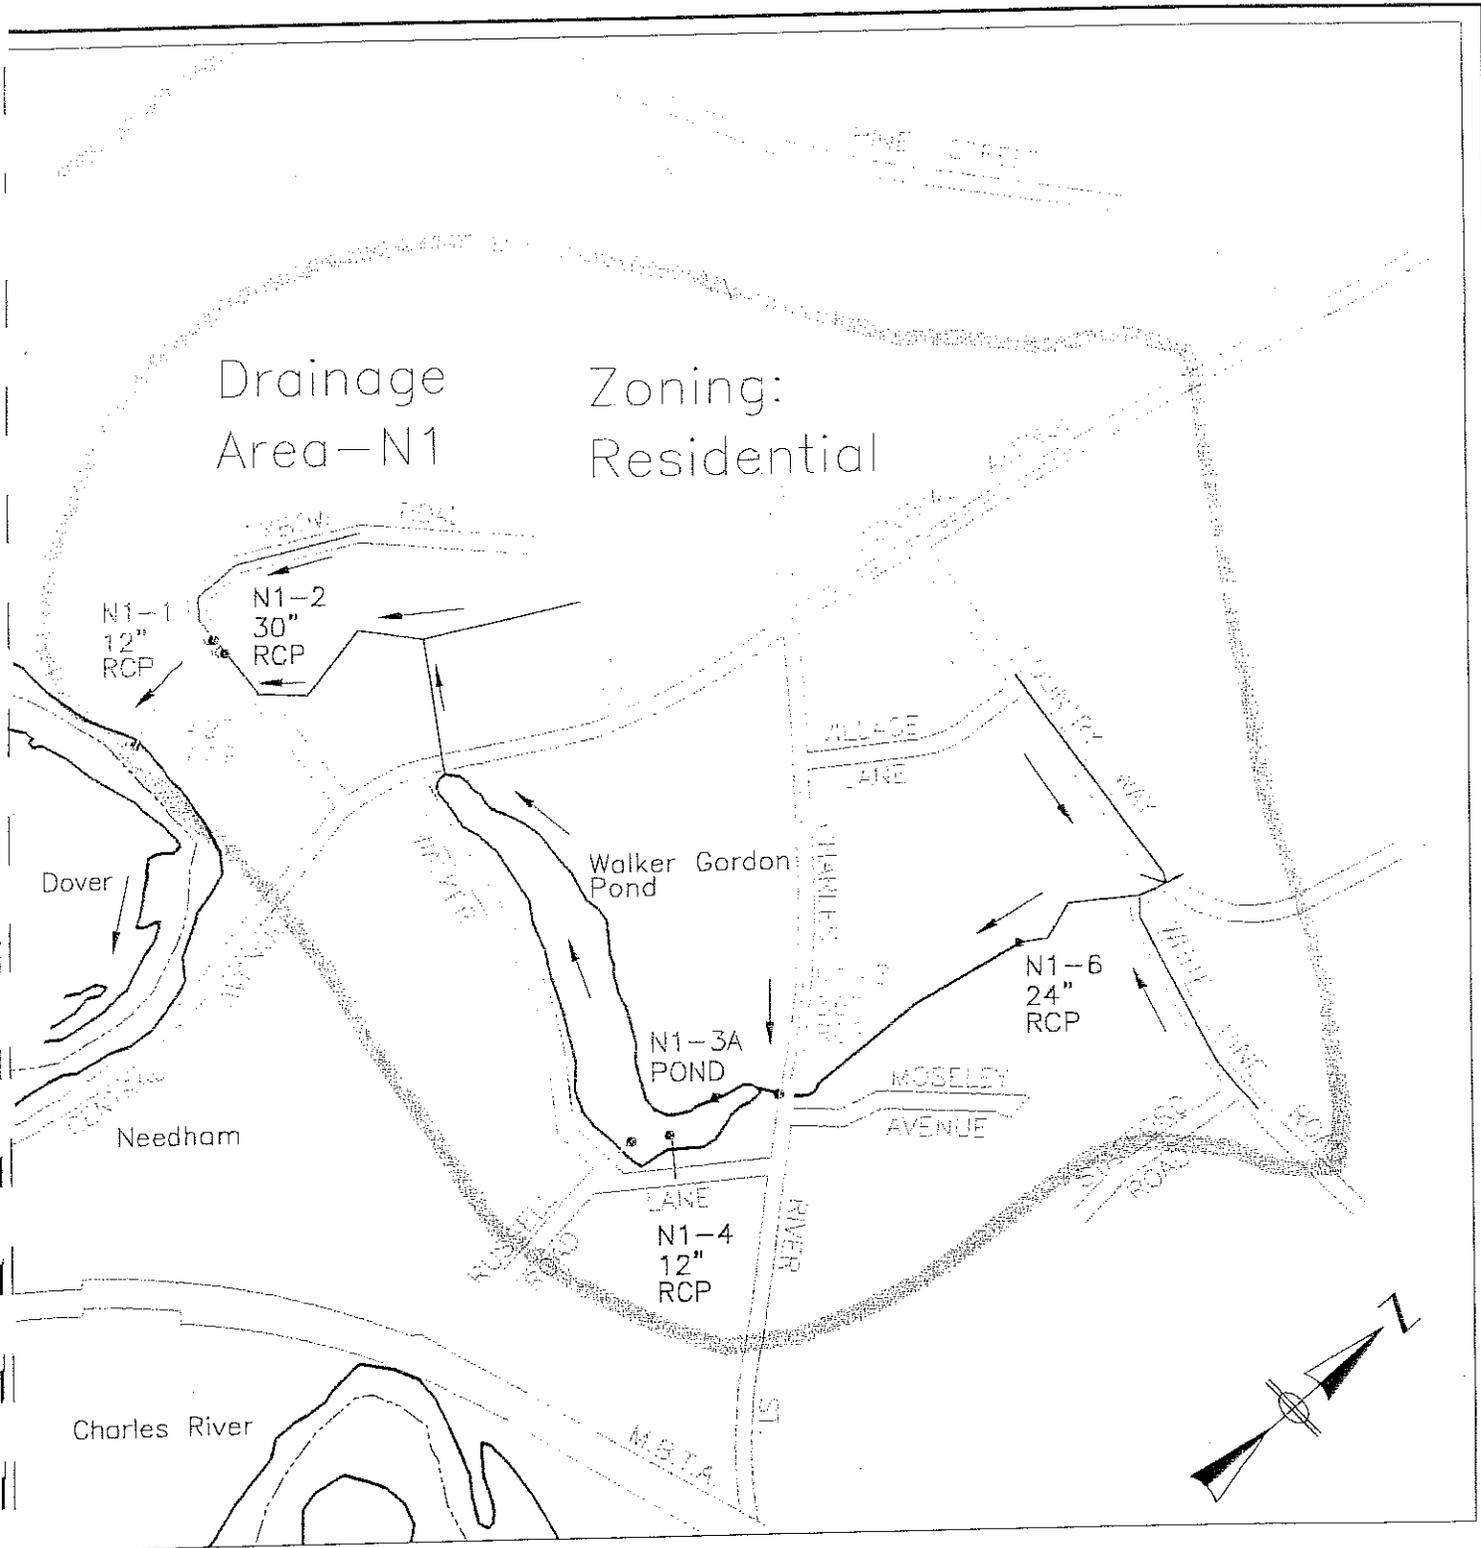
Figure 3.5 - Area Layout
 Drainage Area - N1
 Needham Stormwater Management

This drainage area consists of approximately 200 acres. The area is characterized by residential land use. There are six sub-area discharge points within the area. All of the cumulative flow enters the Charles River through a 42-inch RCP located south of Oxbow Road, as shown in Figure 3.5.

- total length of drainage pipe in this area is approximately 7,550 linear feet
- drainage systems within area N1 include 37 catch basins
- most of the area is sewerred with a few remaining septic systems
- Country Way is now sewerred, but was a problem due to the soils and shallow bedrock in the 1980's
- various breeds of wild life, specifically Canada Geese, migrate in the area. Many geese were noted in Walker Gordon Pond (numerous geese feces also observed) and adjacent athletic fields
- septic systems are located along Walker Gordon Pond
- the Walker Gordon Pond acts as a detention/retention pond half of the discharge area
- Walker Gordon Pond discharges directly to drainage pipes that flow to the Charles River.
- stormwater discharges from a 42 inch reinforced concrete pipe directly to Charles River

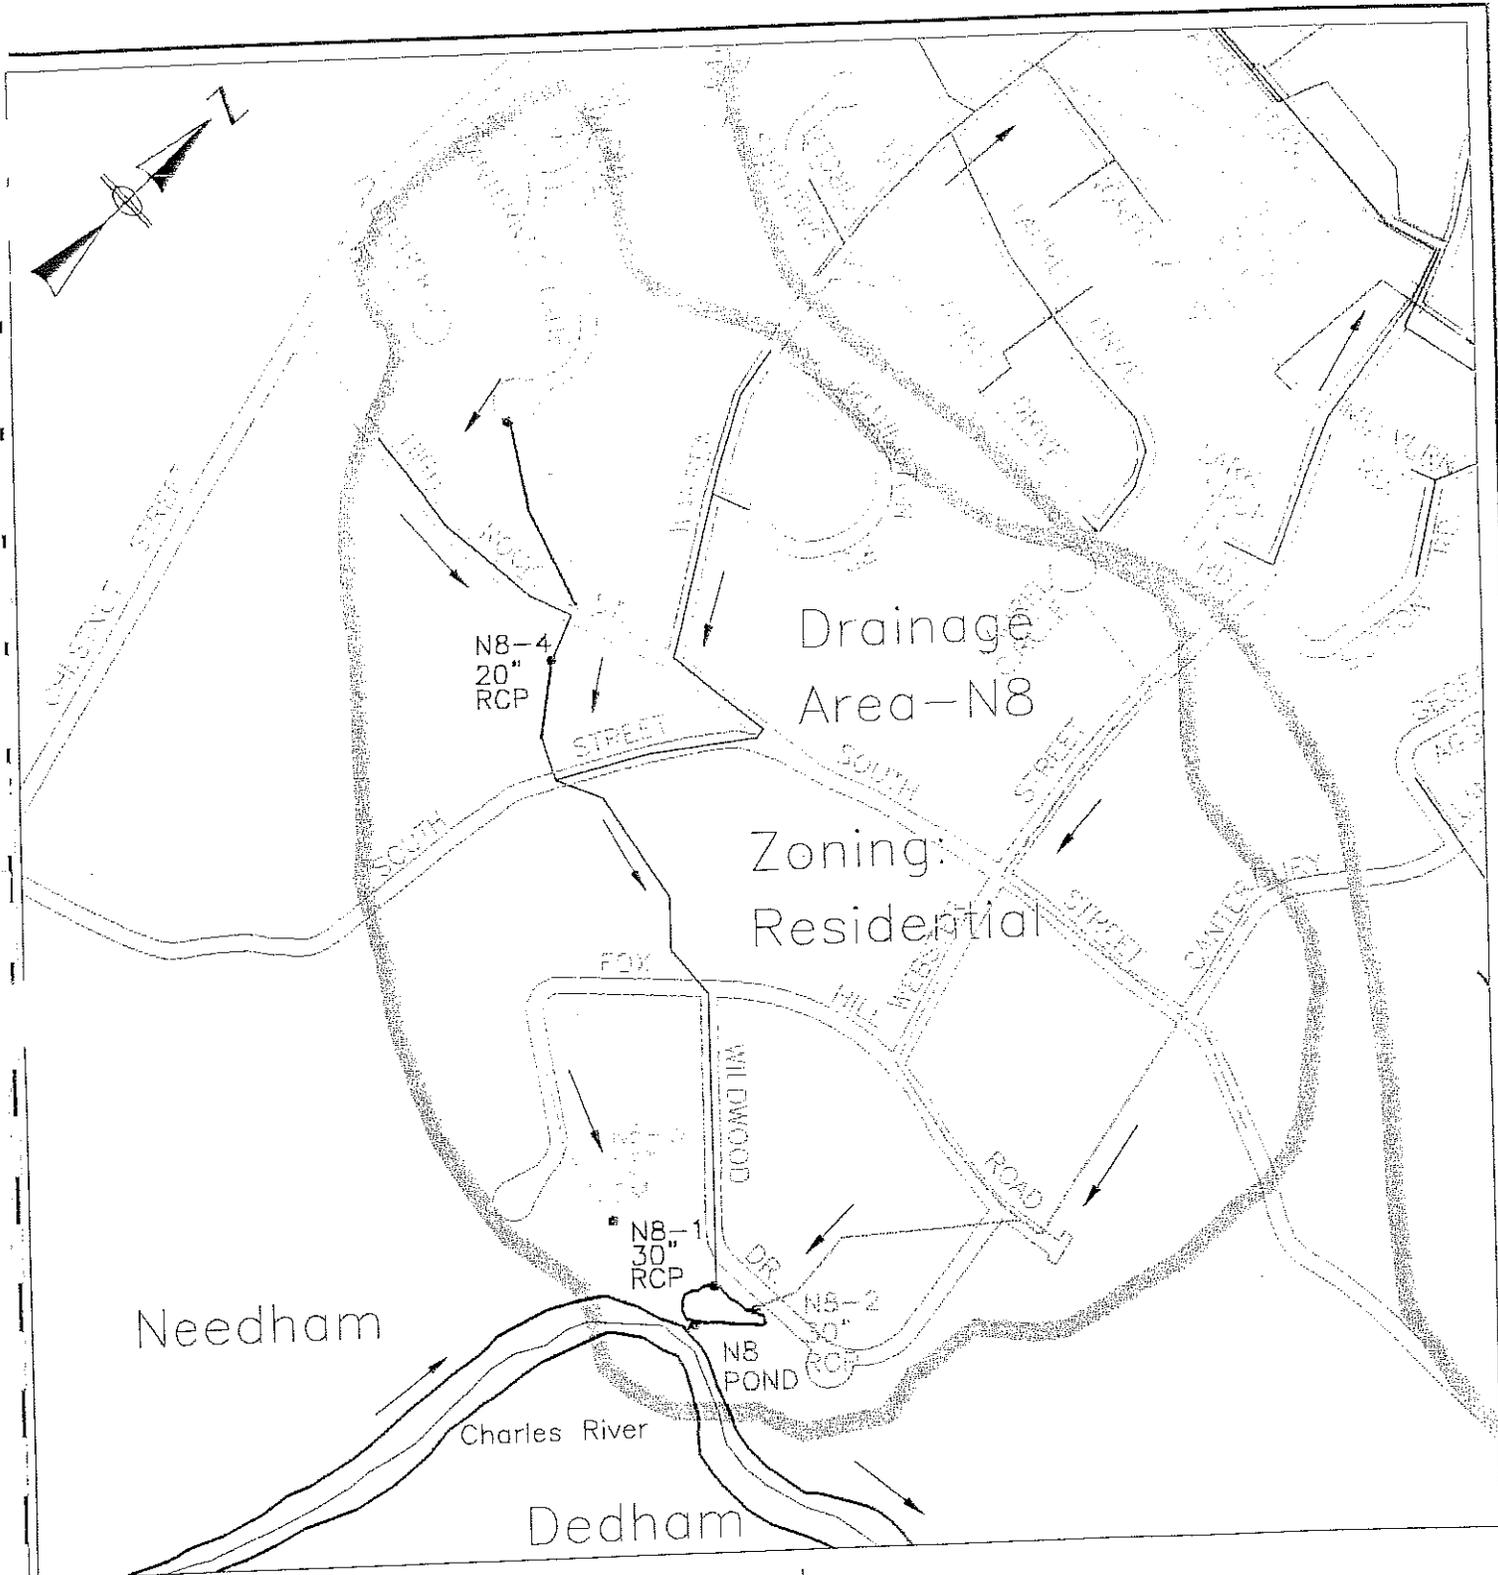
Figure 3.18 - Area Layout
 Drainage Area - N8
 Needham Stormwater Management

This drainage area is approximately 175 acres in size. The area is characterized by residential land use. There are five (5) sub-area discharge points located in the area (see Figure 3.18).
