Figure 3.27 - Area Layout
 Drainage Area - N10A
 Needham Stormwater Management

Stormwater Drain Outfall Inspection Report

PROJECT NAME: Needham, MA Stormwater Investigation

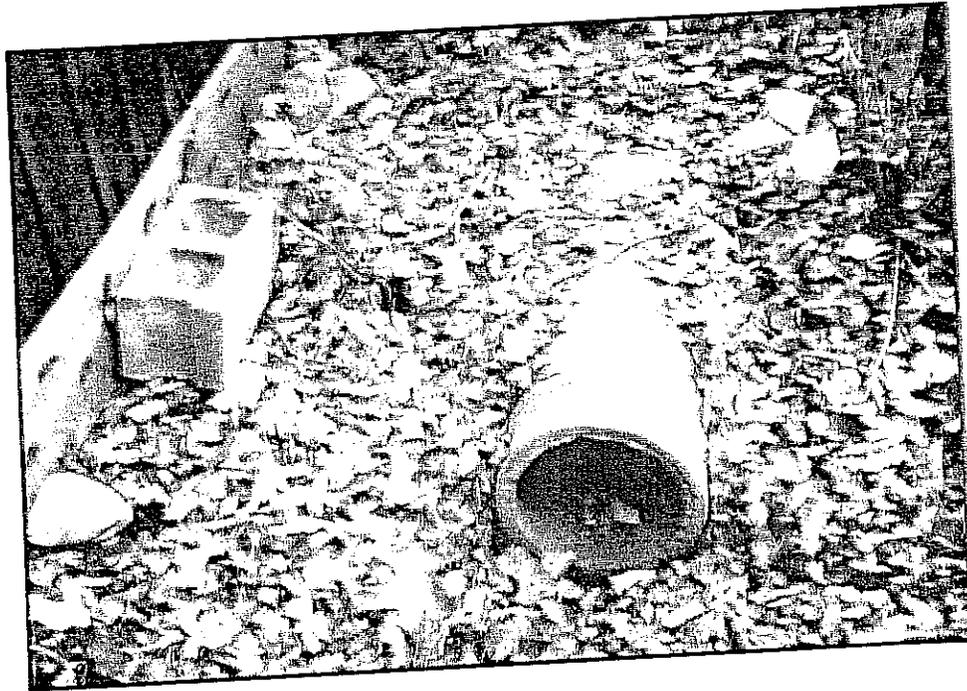
Pipe Size: 12 in Flow Estimate: Dry gpm
Pipe Material/Condition: RCP/Good Last Precipitation: 10/30/96
Clarity of Flow/Turbidity: NA

Comments: No evidence of recent flow.

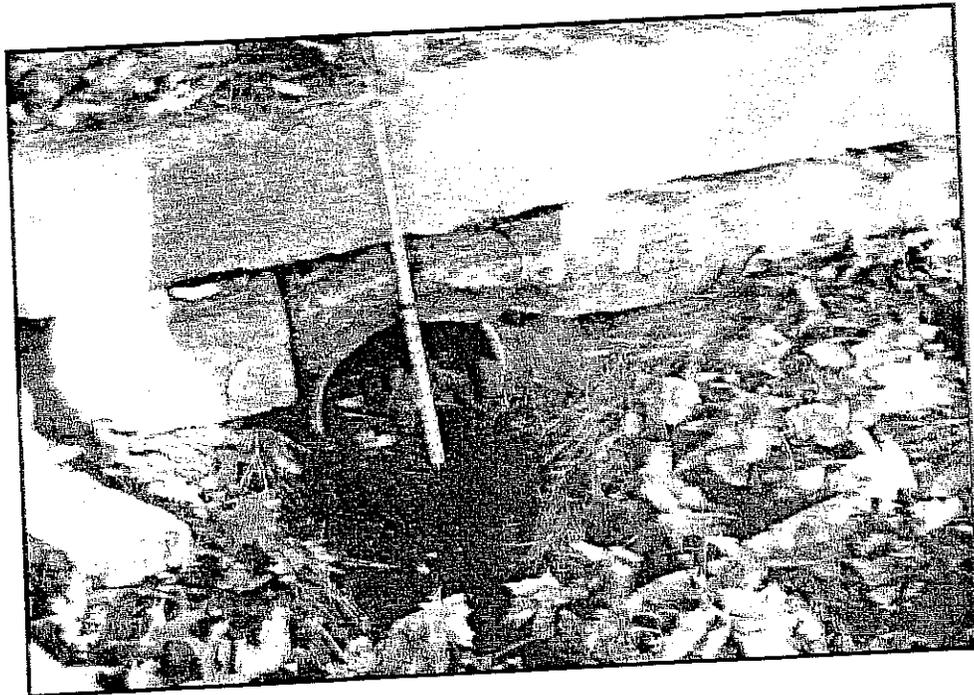
Pipe Size: 12 in Flow Estimate: Dry gpm
Pipe Material/Condition: PVC/Good Last Precipitation: 10/30/96
Clarity of Flow/Turbidity: NA

Comments: No evidence of recent flow.

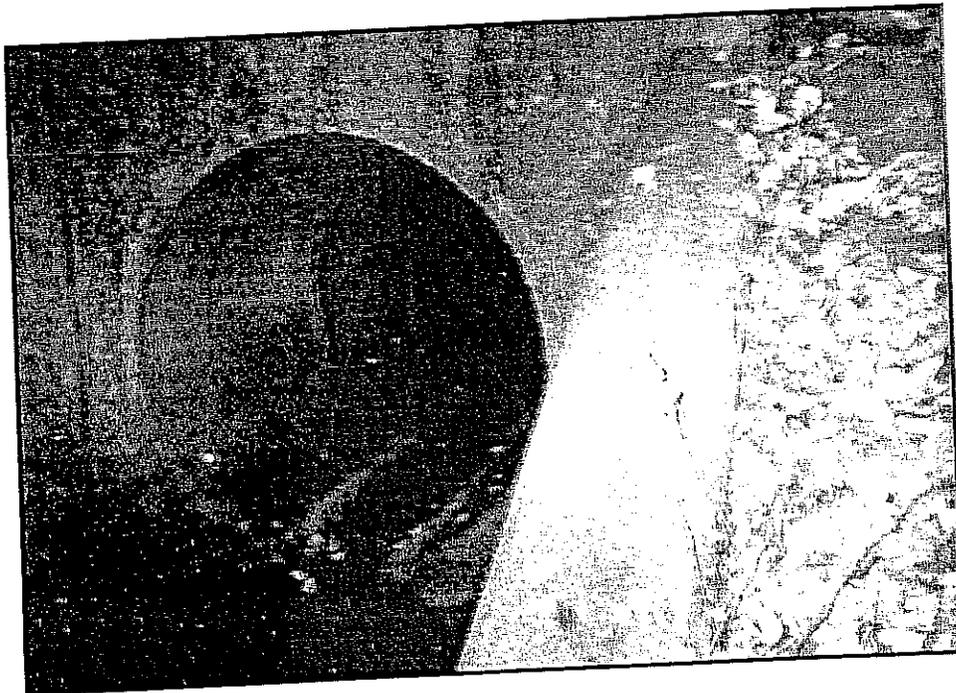
Pipe Size: 48 in Flow Estimate: 1 gpm
Pipe Material/Condition: RCP/Good Last Precipitation: 9/29/96
Clarity of Flow/Turbidity: Clear

Comments: No floatables or discoloration were observed in the pipe.

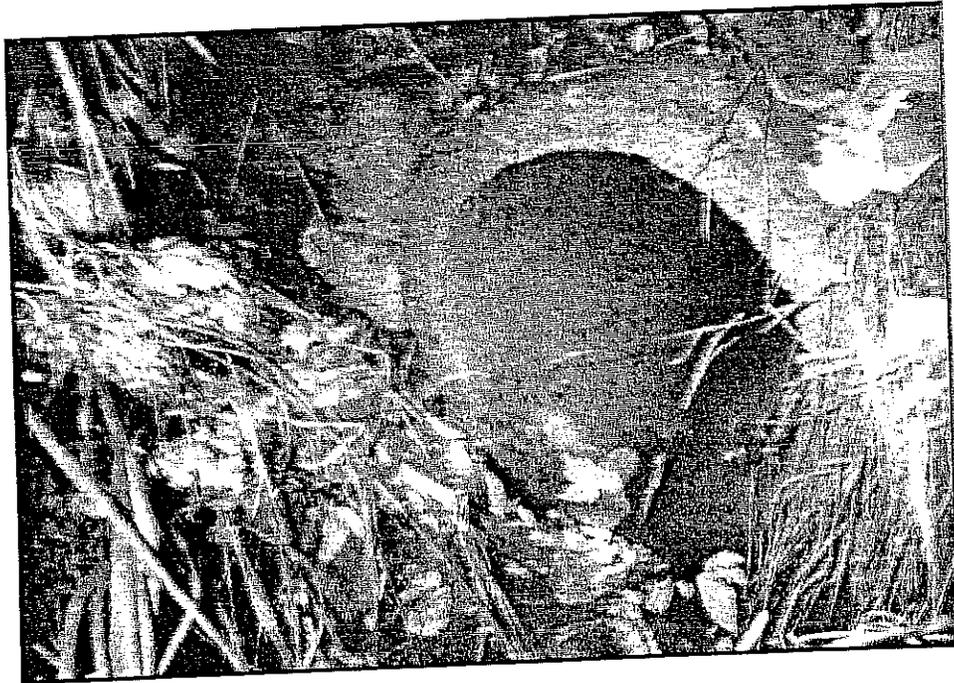
Pipe Size: 18 in.
Pipe Material/Condition: RCP/Good
Flow Estimate: Dry gpm
Last Precipitation: 10/9/96
Clarity of Flow/Turbidity: NA

Comments: No evidence of recent flow.

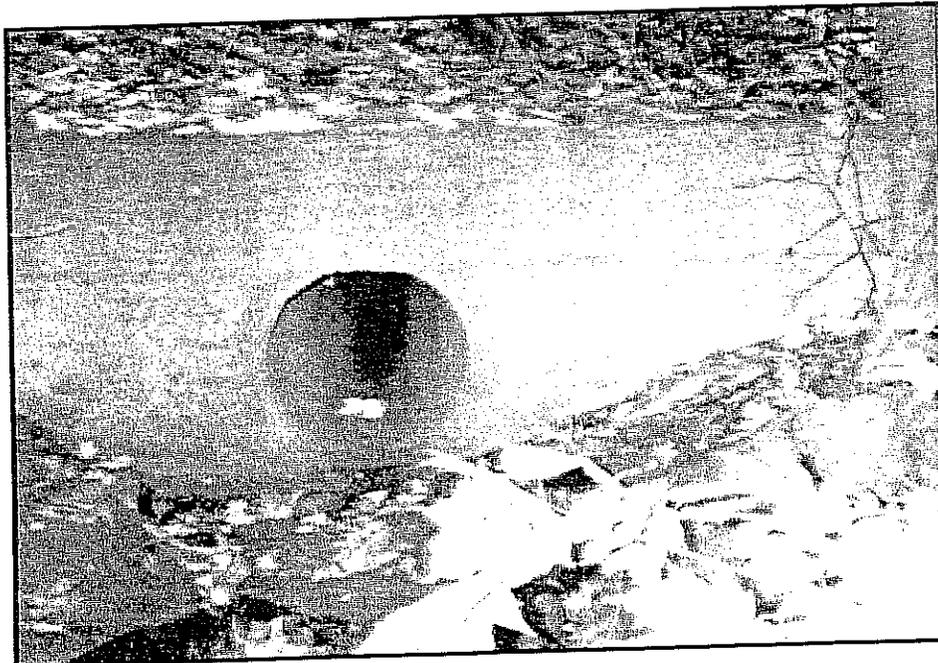
Pipe Size: 18 in. Flow Estimate: Dry gpm
Pipe Material/Condition: RCP/Good Last Precipitation: 9/29/96
Clarity of Flow/Turbidity: NA

Comments: No evidence of recent flow.
